BEACH AND PICNIC AREA **EXISTING CONDITIONS**

BEACH AND PICNIC AREA IMPROVEMENTS

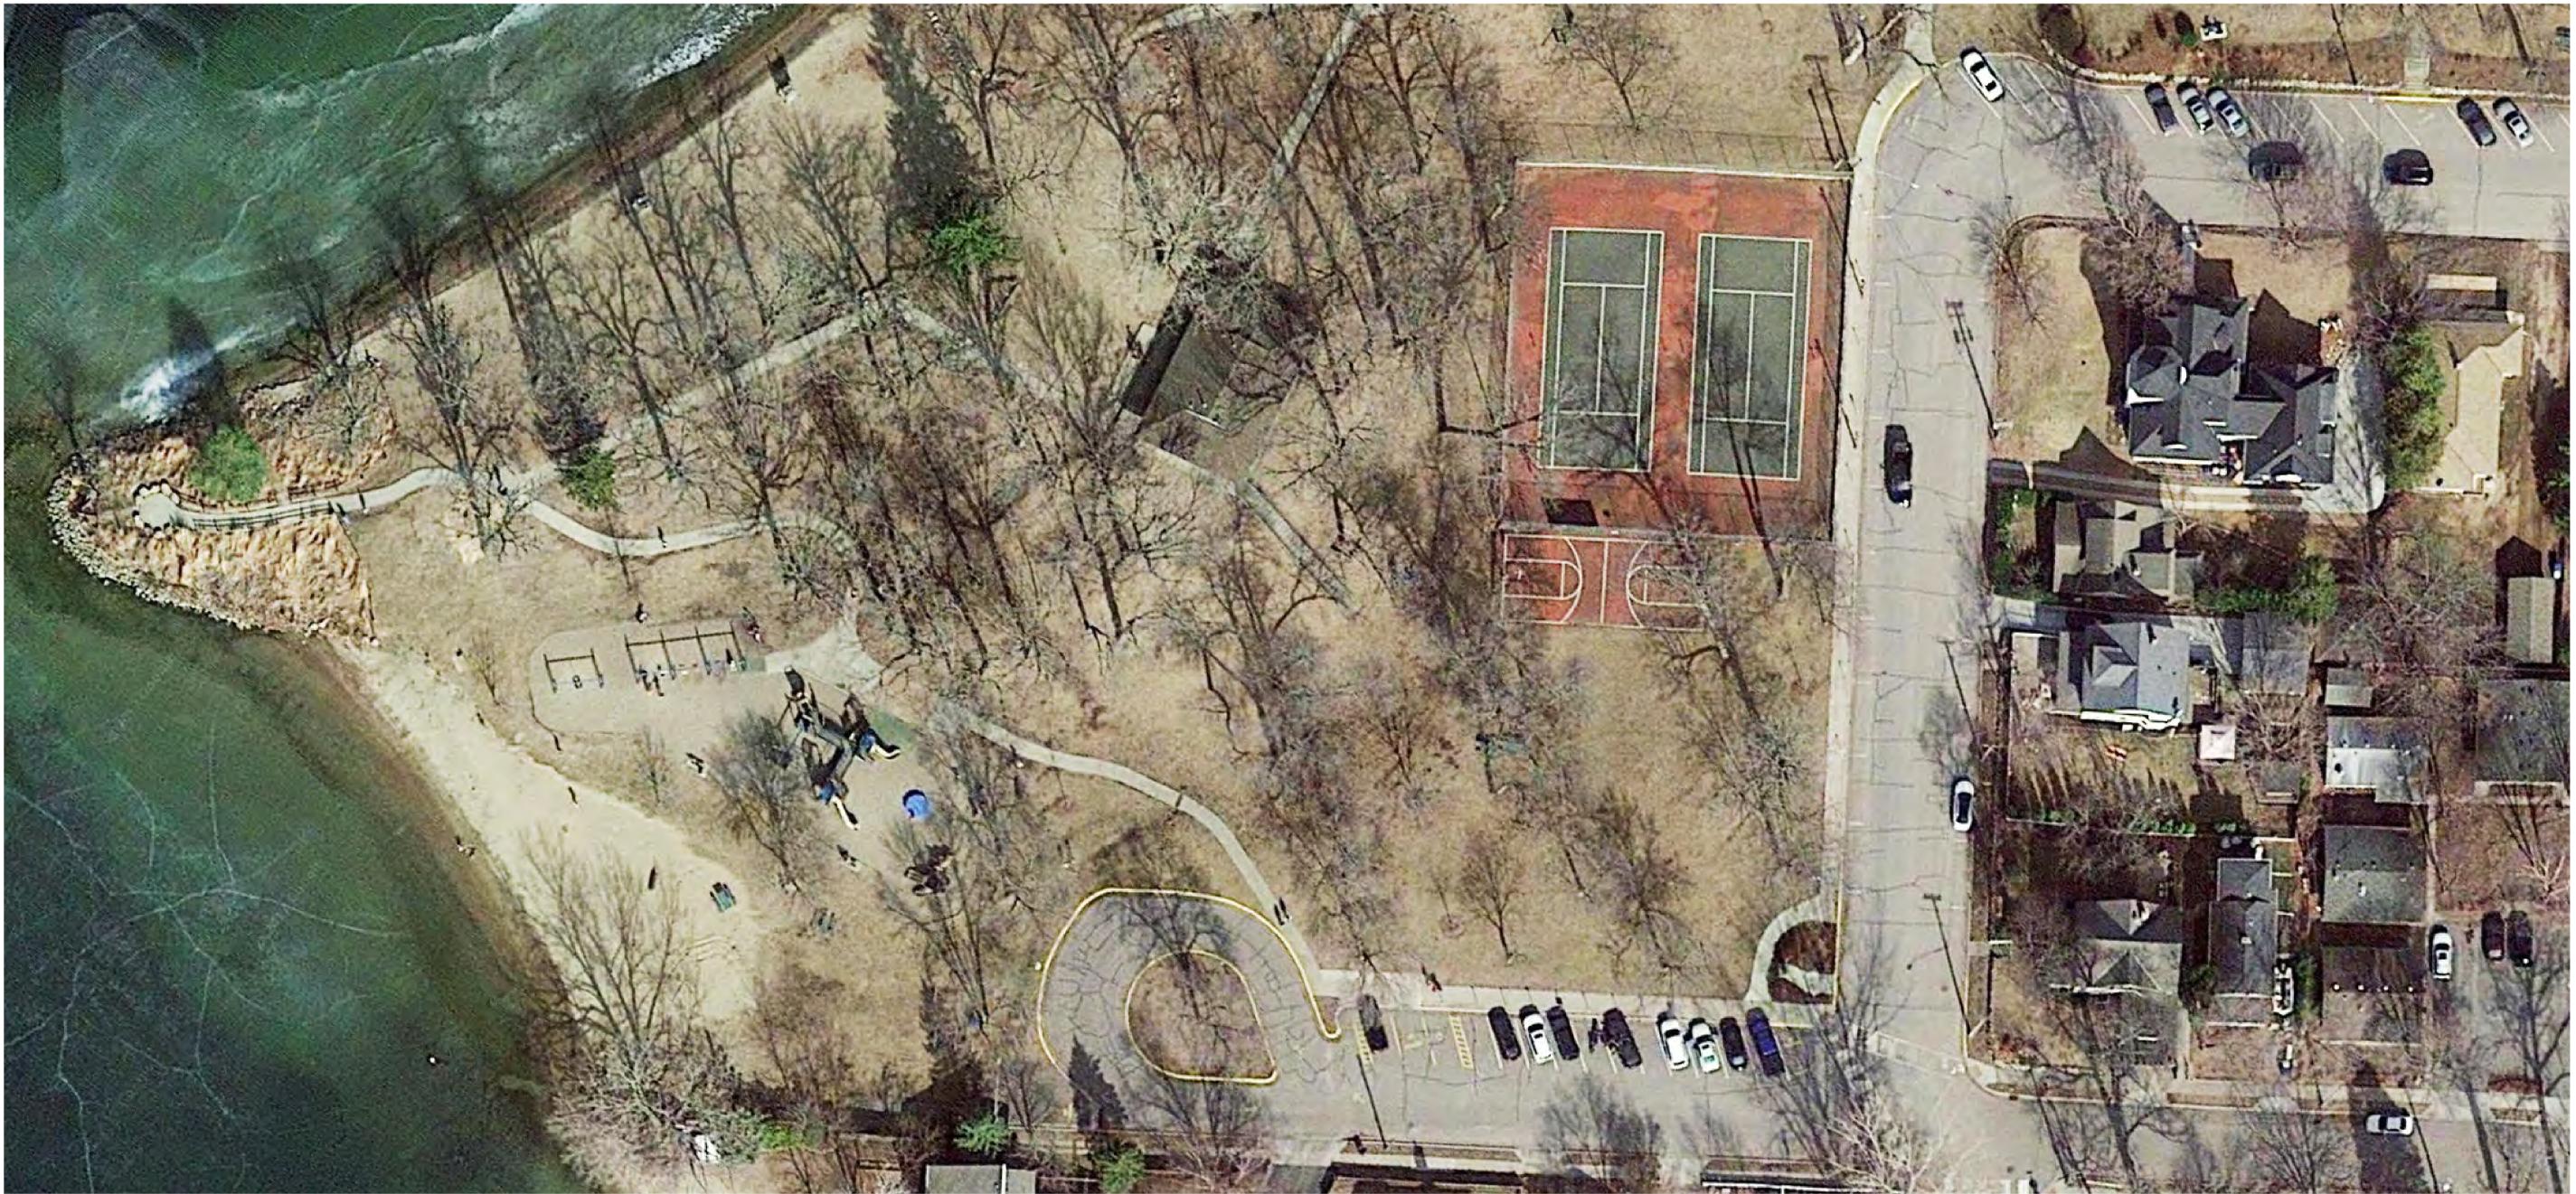
The beach and picnic area sit on a significant knoll within The Commons. This area is an important neighborhood and community destination. The tennis courts, play area, beach, picnic area and restroom/changing building are all showing signs of age. The following issues were identified as areas for improvement:

- Current run-off contributes to frequent beach closings
- Significant erosion on knoll under the existing tree canopy
- Invasive species on knoll hillside along lake edge
- Limited winter recreation opportunities
- Courts are striped for single sport
- More parking is needed
- Restroom building is run down, not ADA accessible and unwelcoming

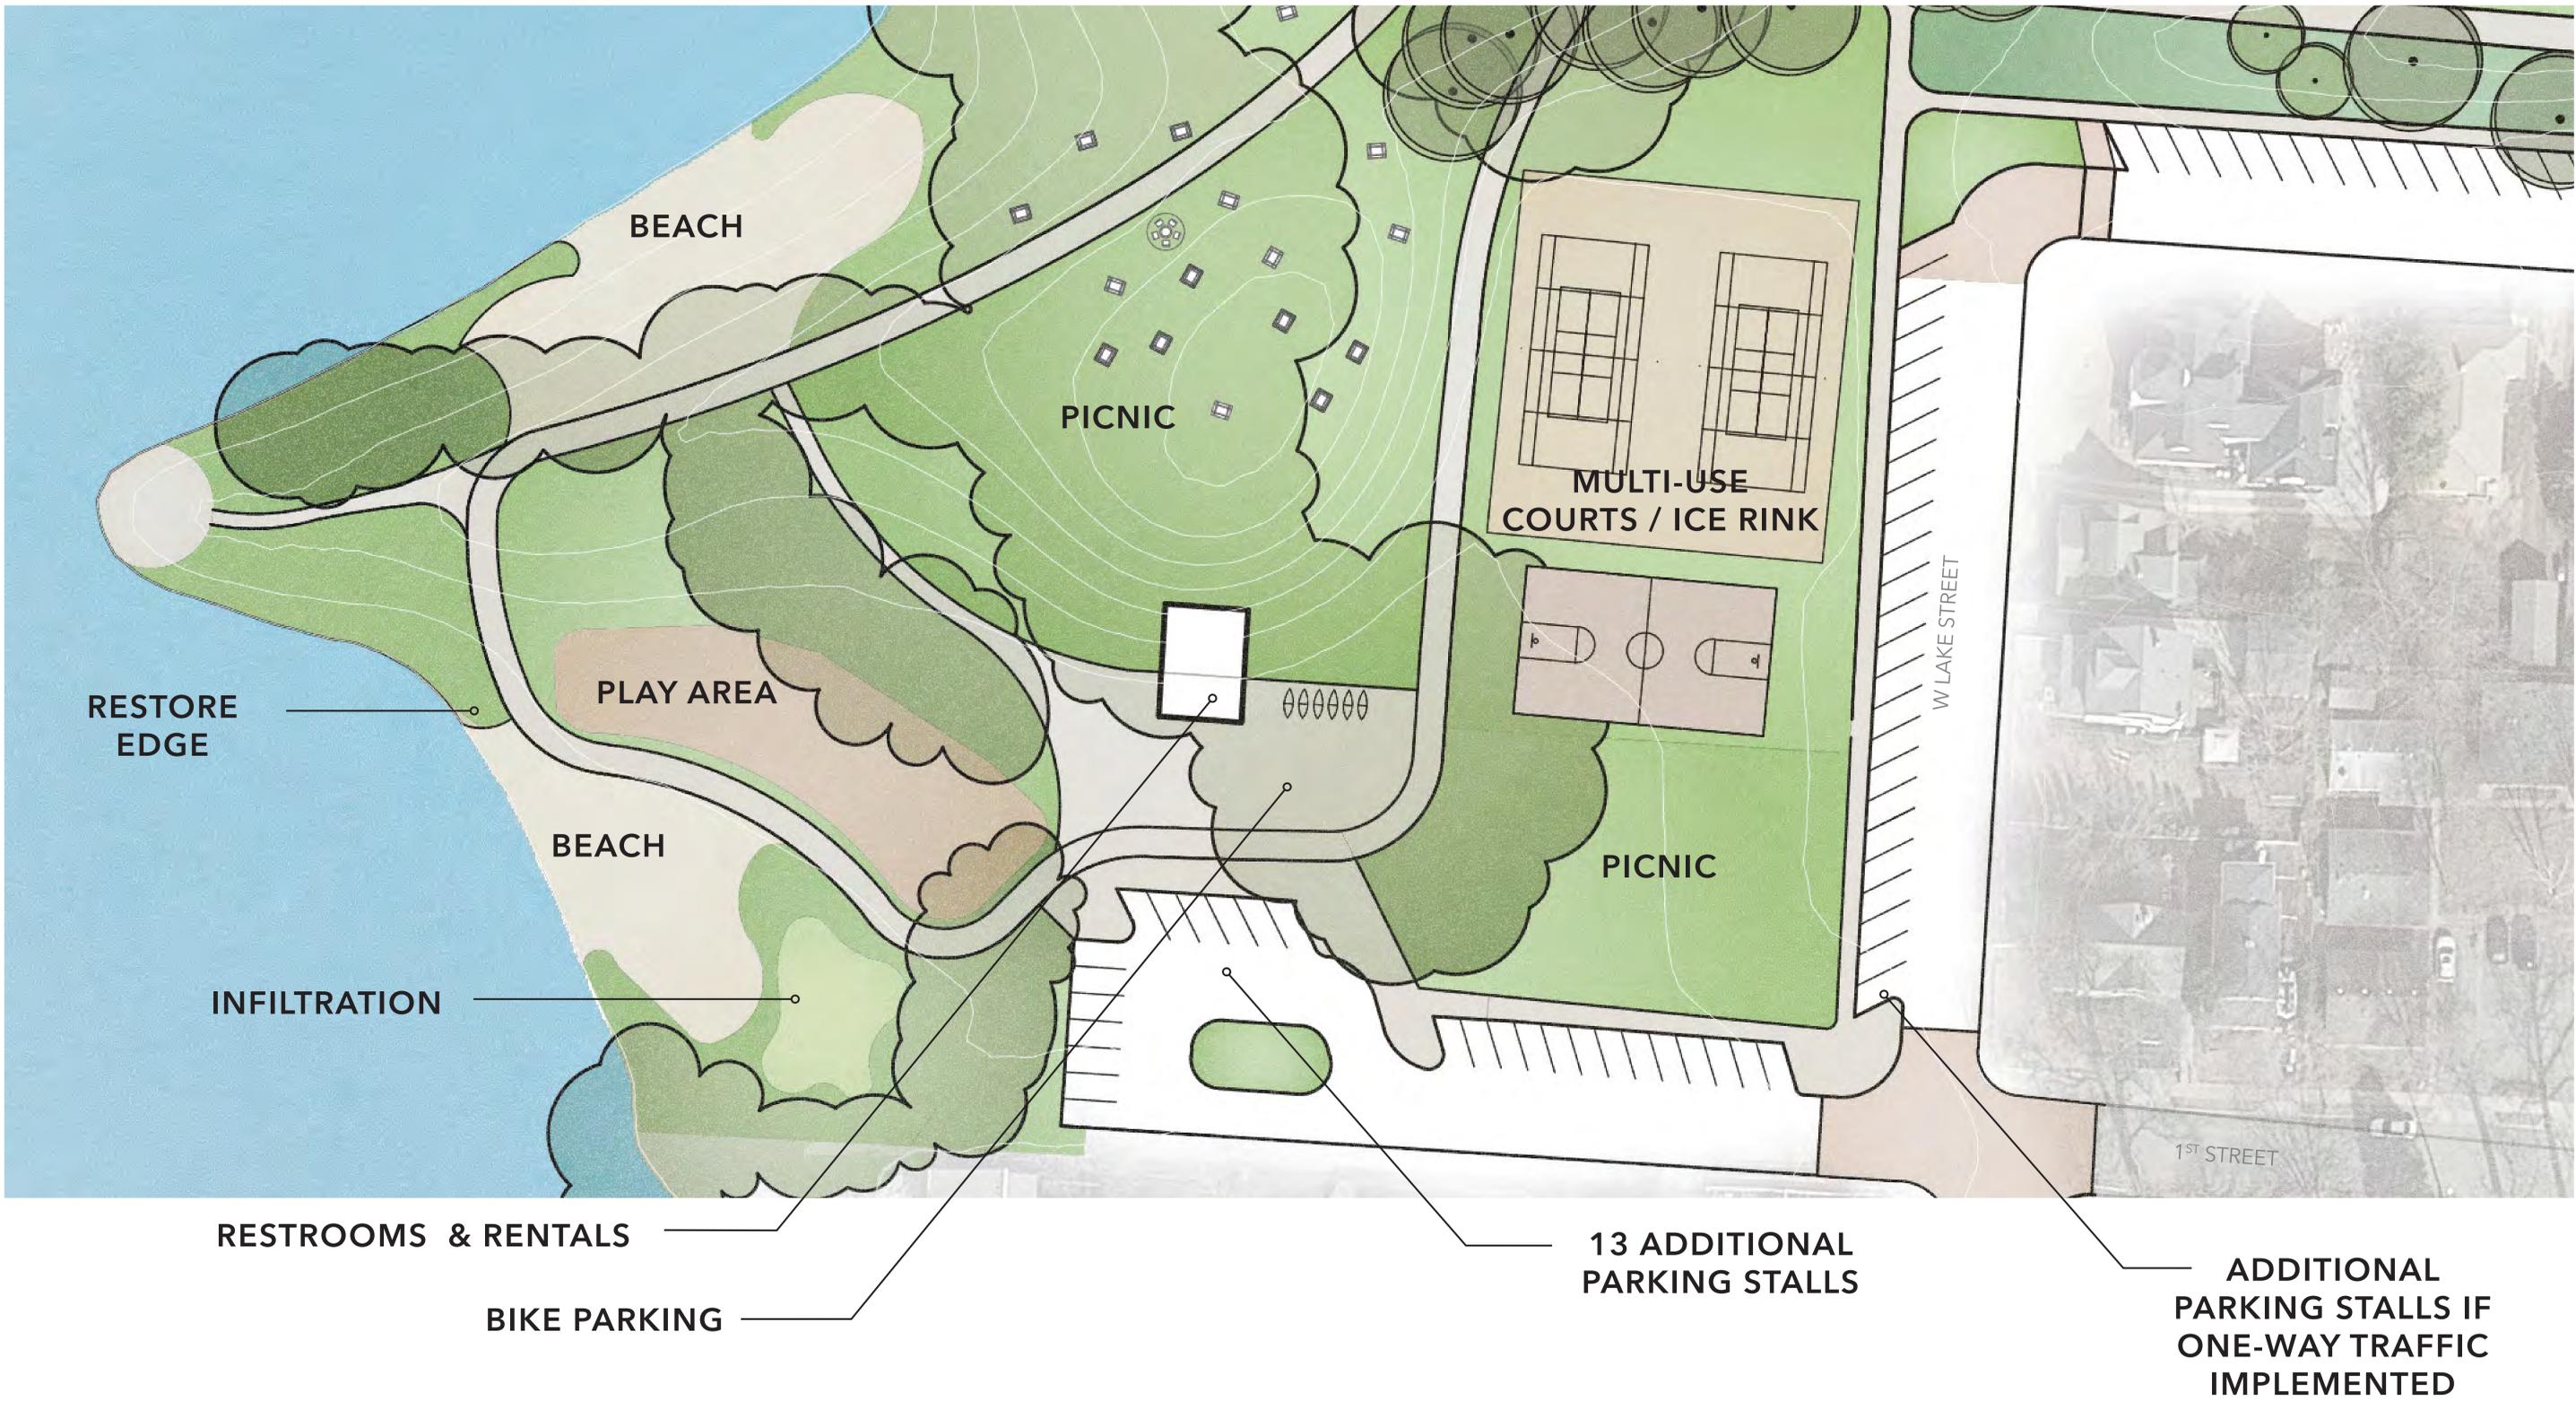
The beach and picnic area offer an important amenity for residents and the master plan envisions a series of improvements that will maintain the natural character of this zone of the park, while better addressing ecological and recreational opportunities. Proposed enhancements include:

- New stalls on West Lake Street and at playground drop-off area add parking capacity with minimal impact on green space.
- A restroom building with space for rental of equipment (i.e. paddle boards, kayaks, skates/skies) and space for a winter warming house. The building would be accessed from roundabout and provide a central hub for activity. A new picnic pavilion for family gatherings would be located at the top of the hill grade.

- Upgrade existing play equipment to address universal accessibility and modern play.
- Provide pretreatment infiltration of road runoff to improve water quality at the beach.

- Enhanced picnic facilities on top of knoll.
- Bike parking.
- Shoreline improvements to minimize erosion into lake.
- Elimination of invasive species on knoll.

- Move courts away from Lake Street to provide improved green buffer and re-purpose for multi-use activity, such as an ice rink.

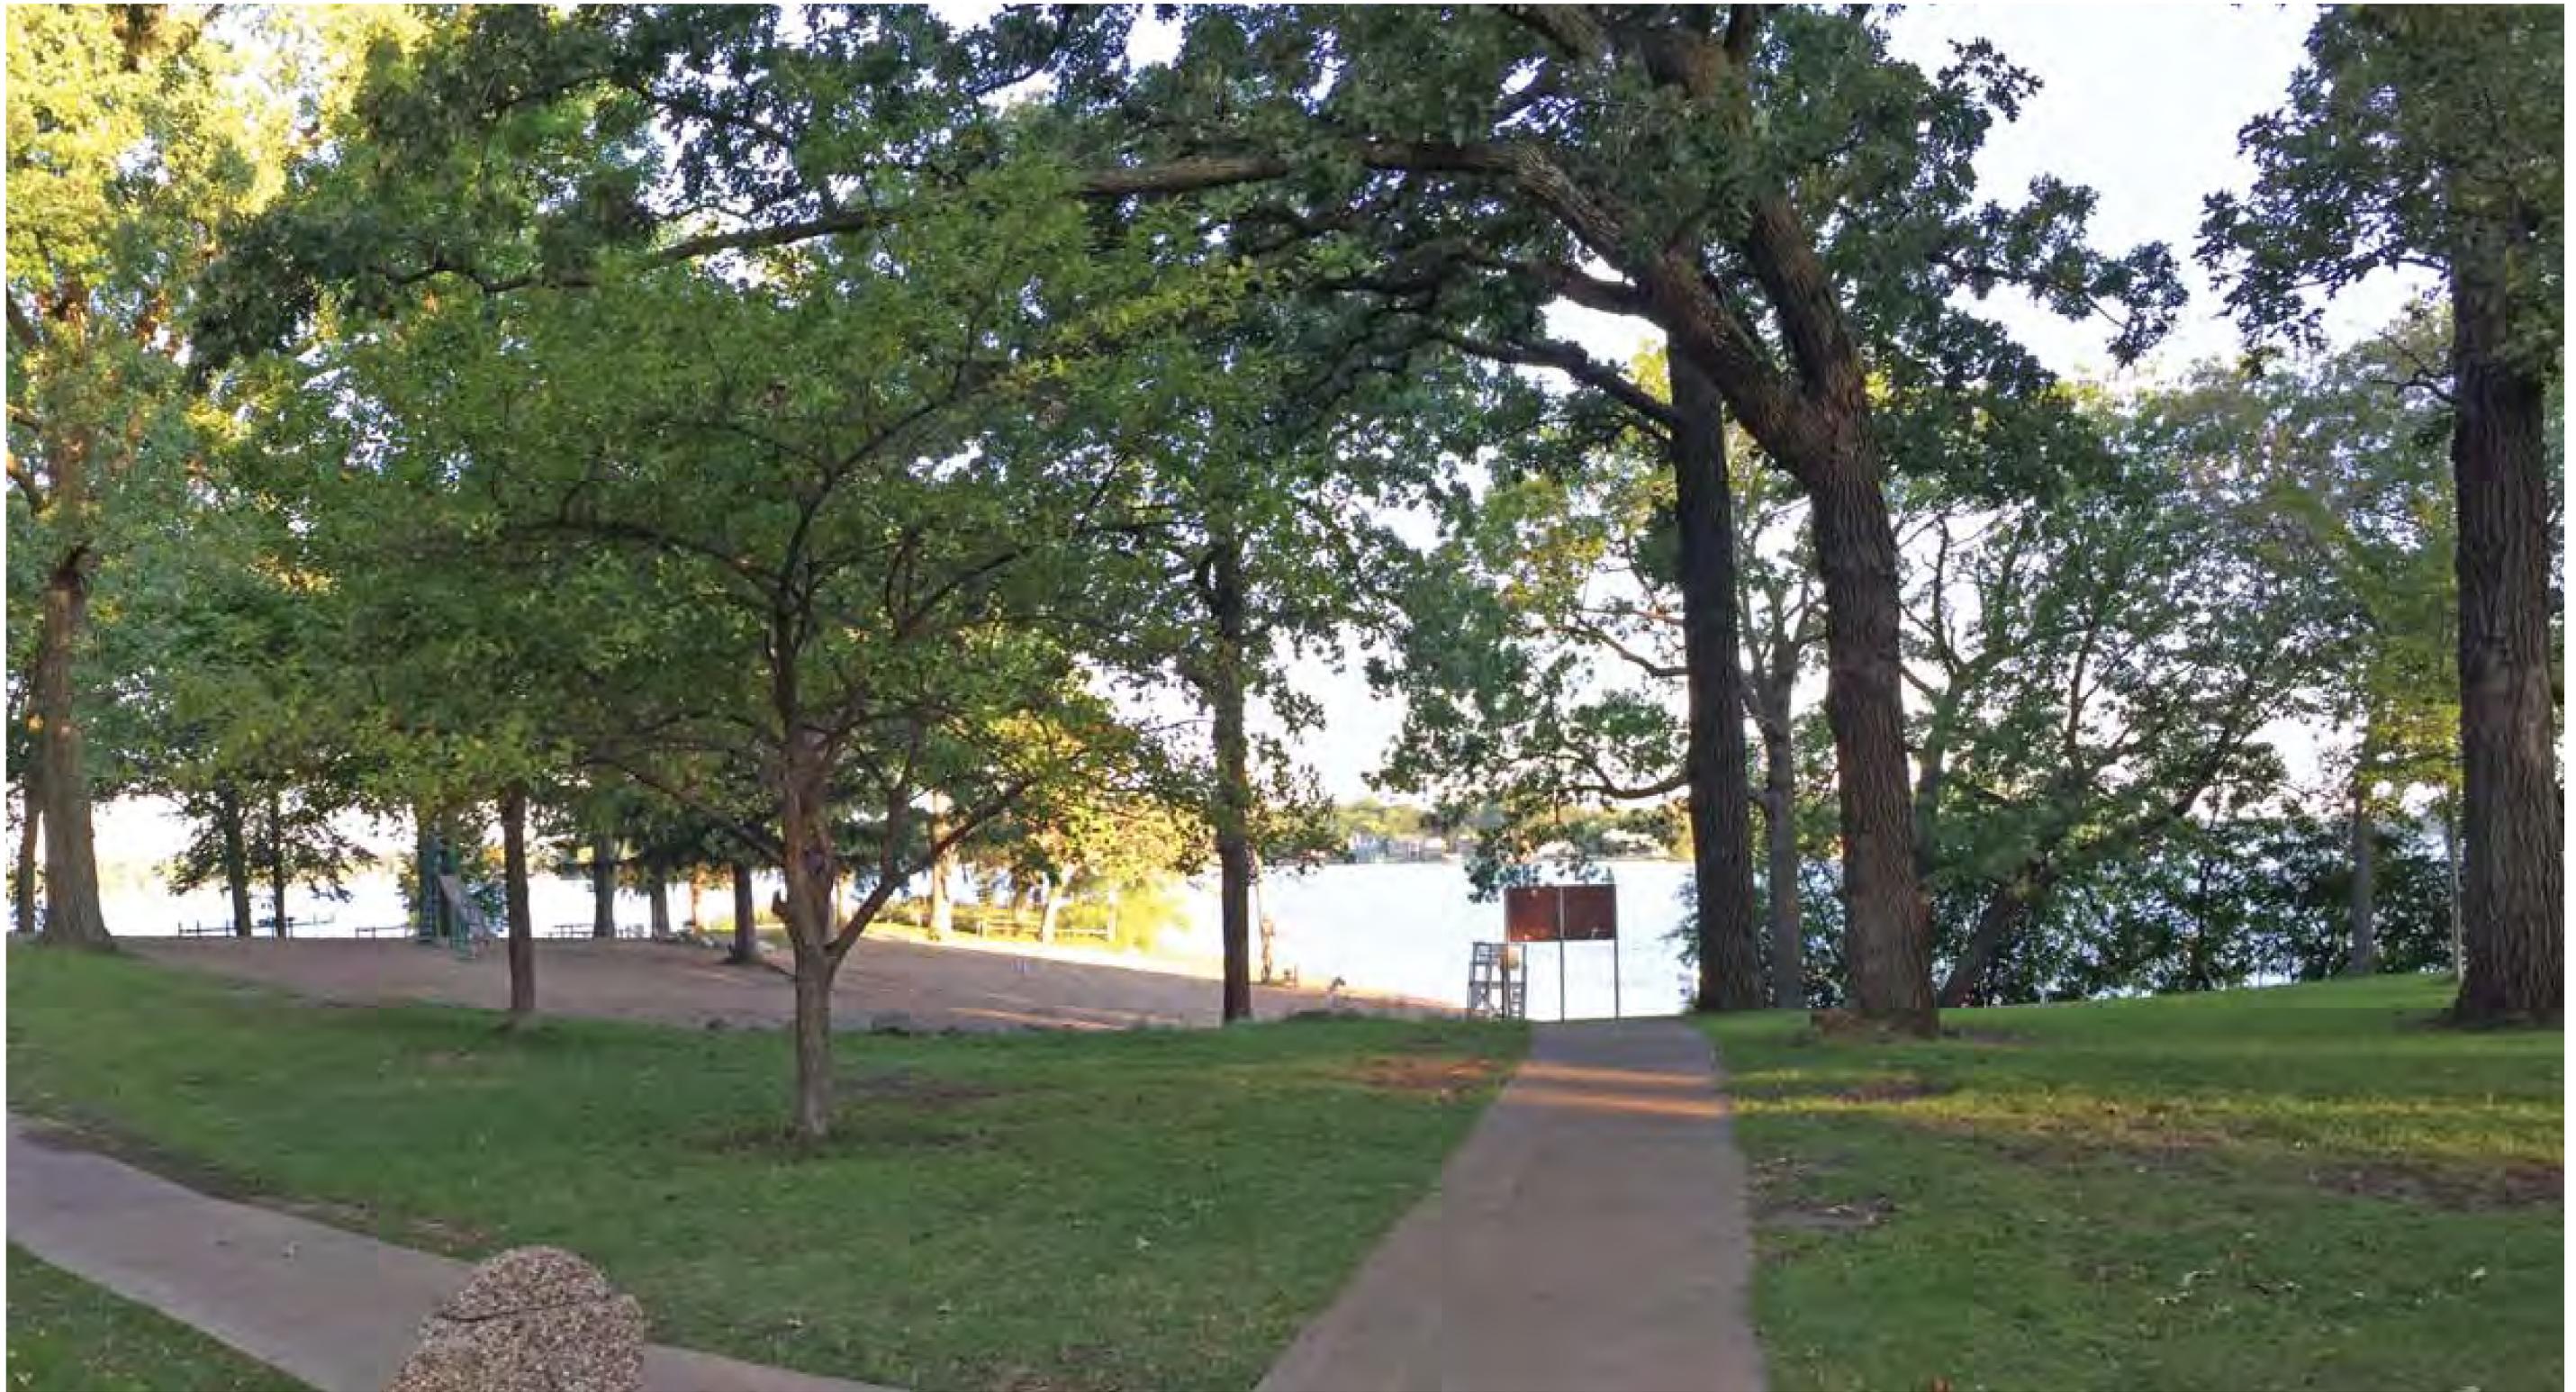
This view taken from the top of the existing knoll illustrates how the existing beach has extended almost to the top of the knoll and created erosion issues, the limited amount of picnic tables, the unwelcoming restroom building and the invasive species along the knoll hillsides adjacent to the Lake.

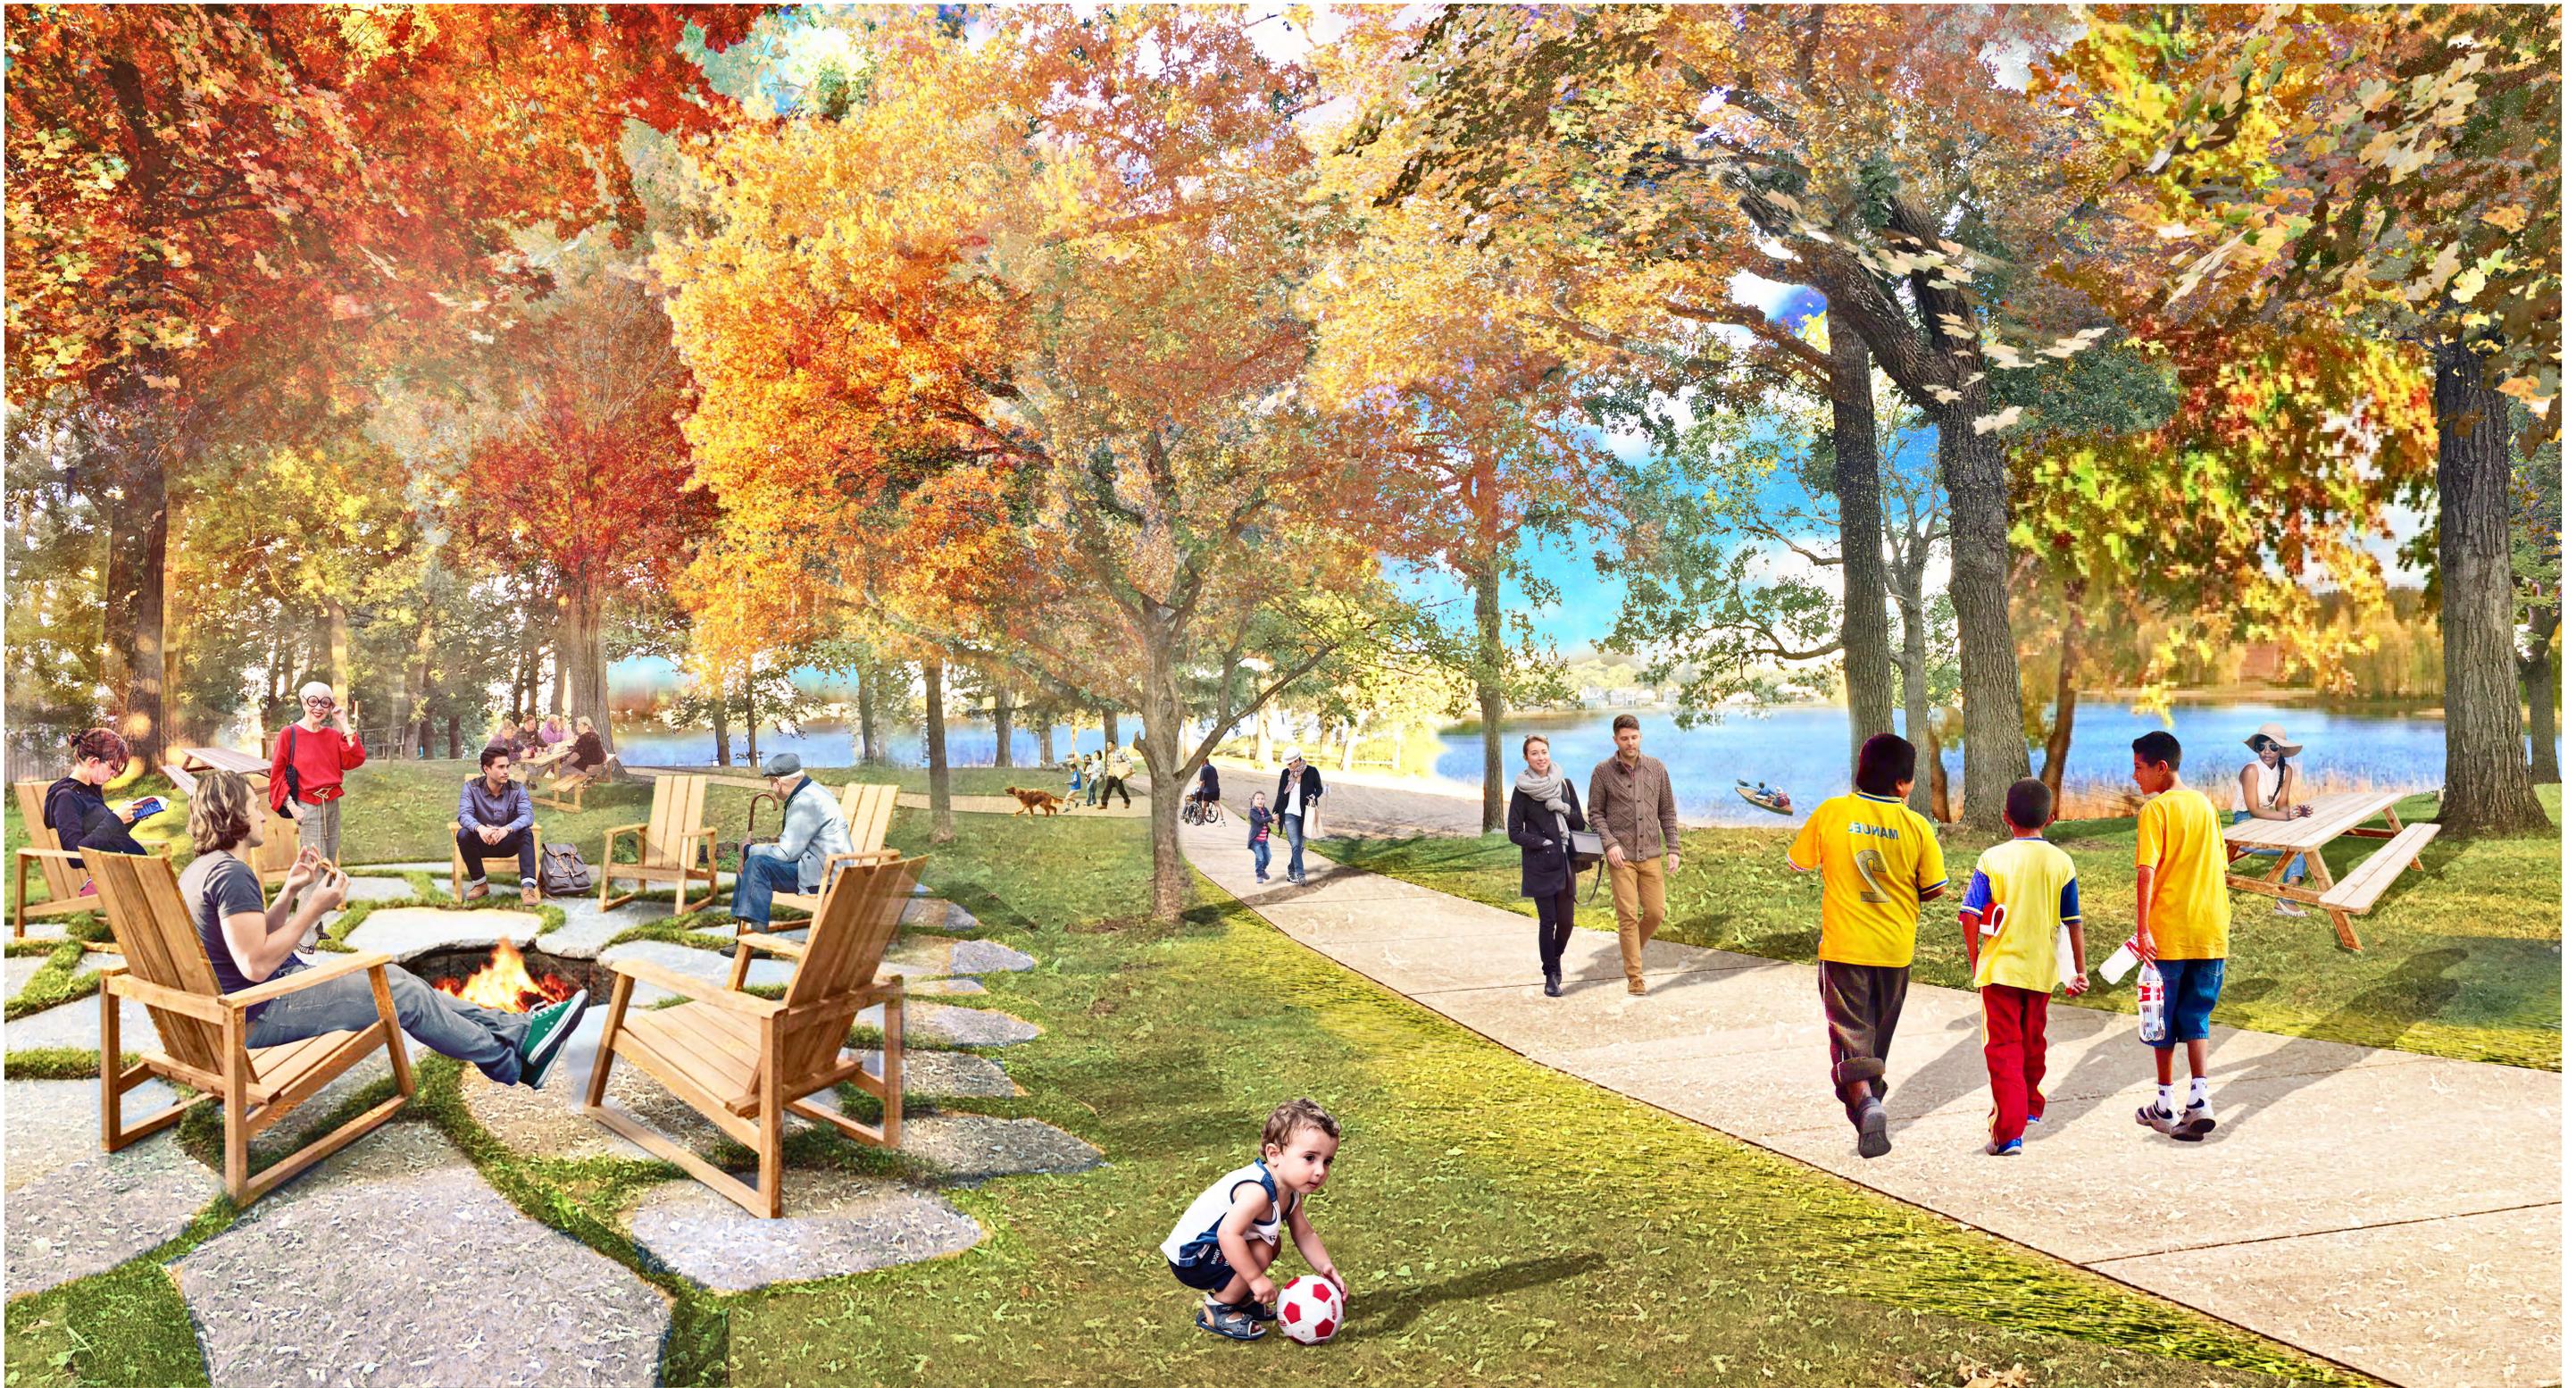
The proposed illustration reflects a Minnesota fall day with enhanced picnic opportunities, restoration of vegetation between the beach and the top of the knoll and removal of invasive species along the lake edge.

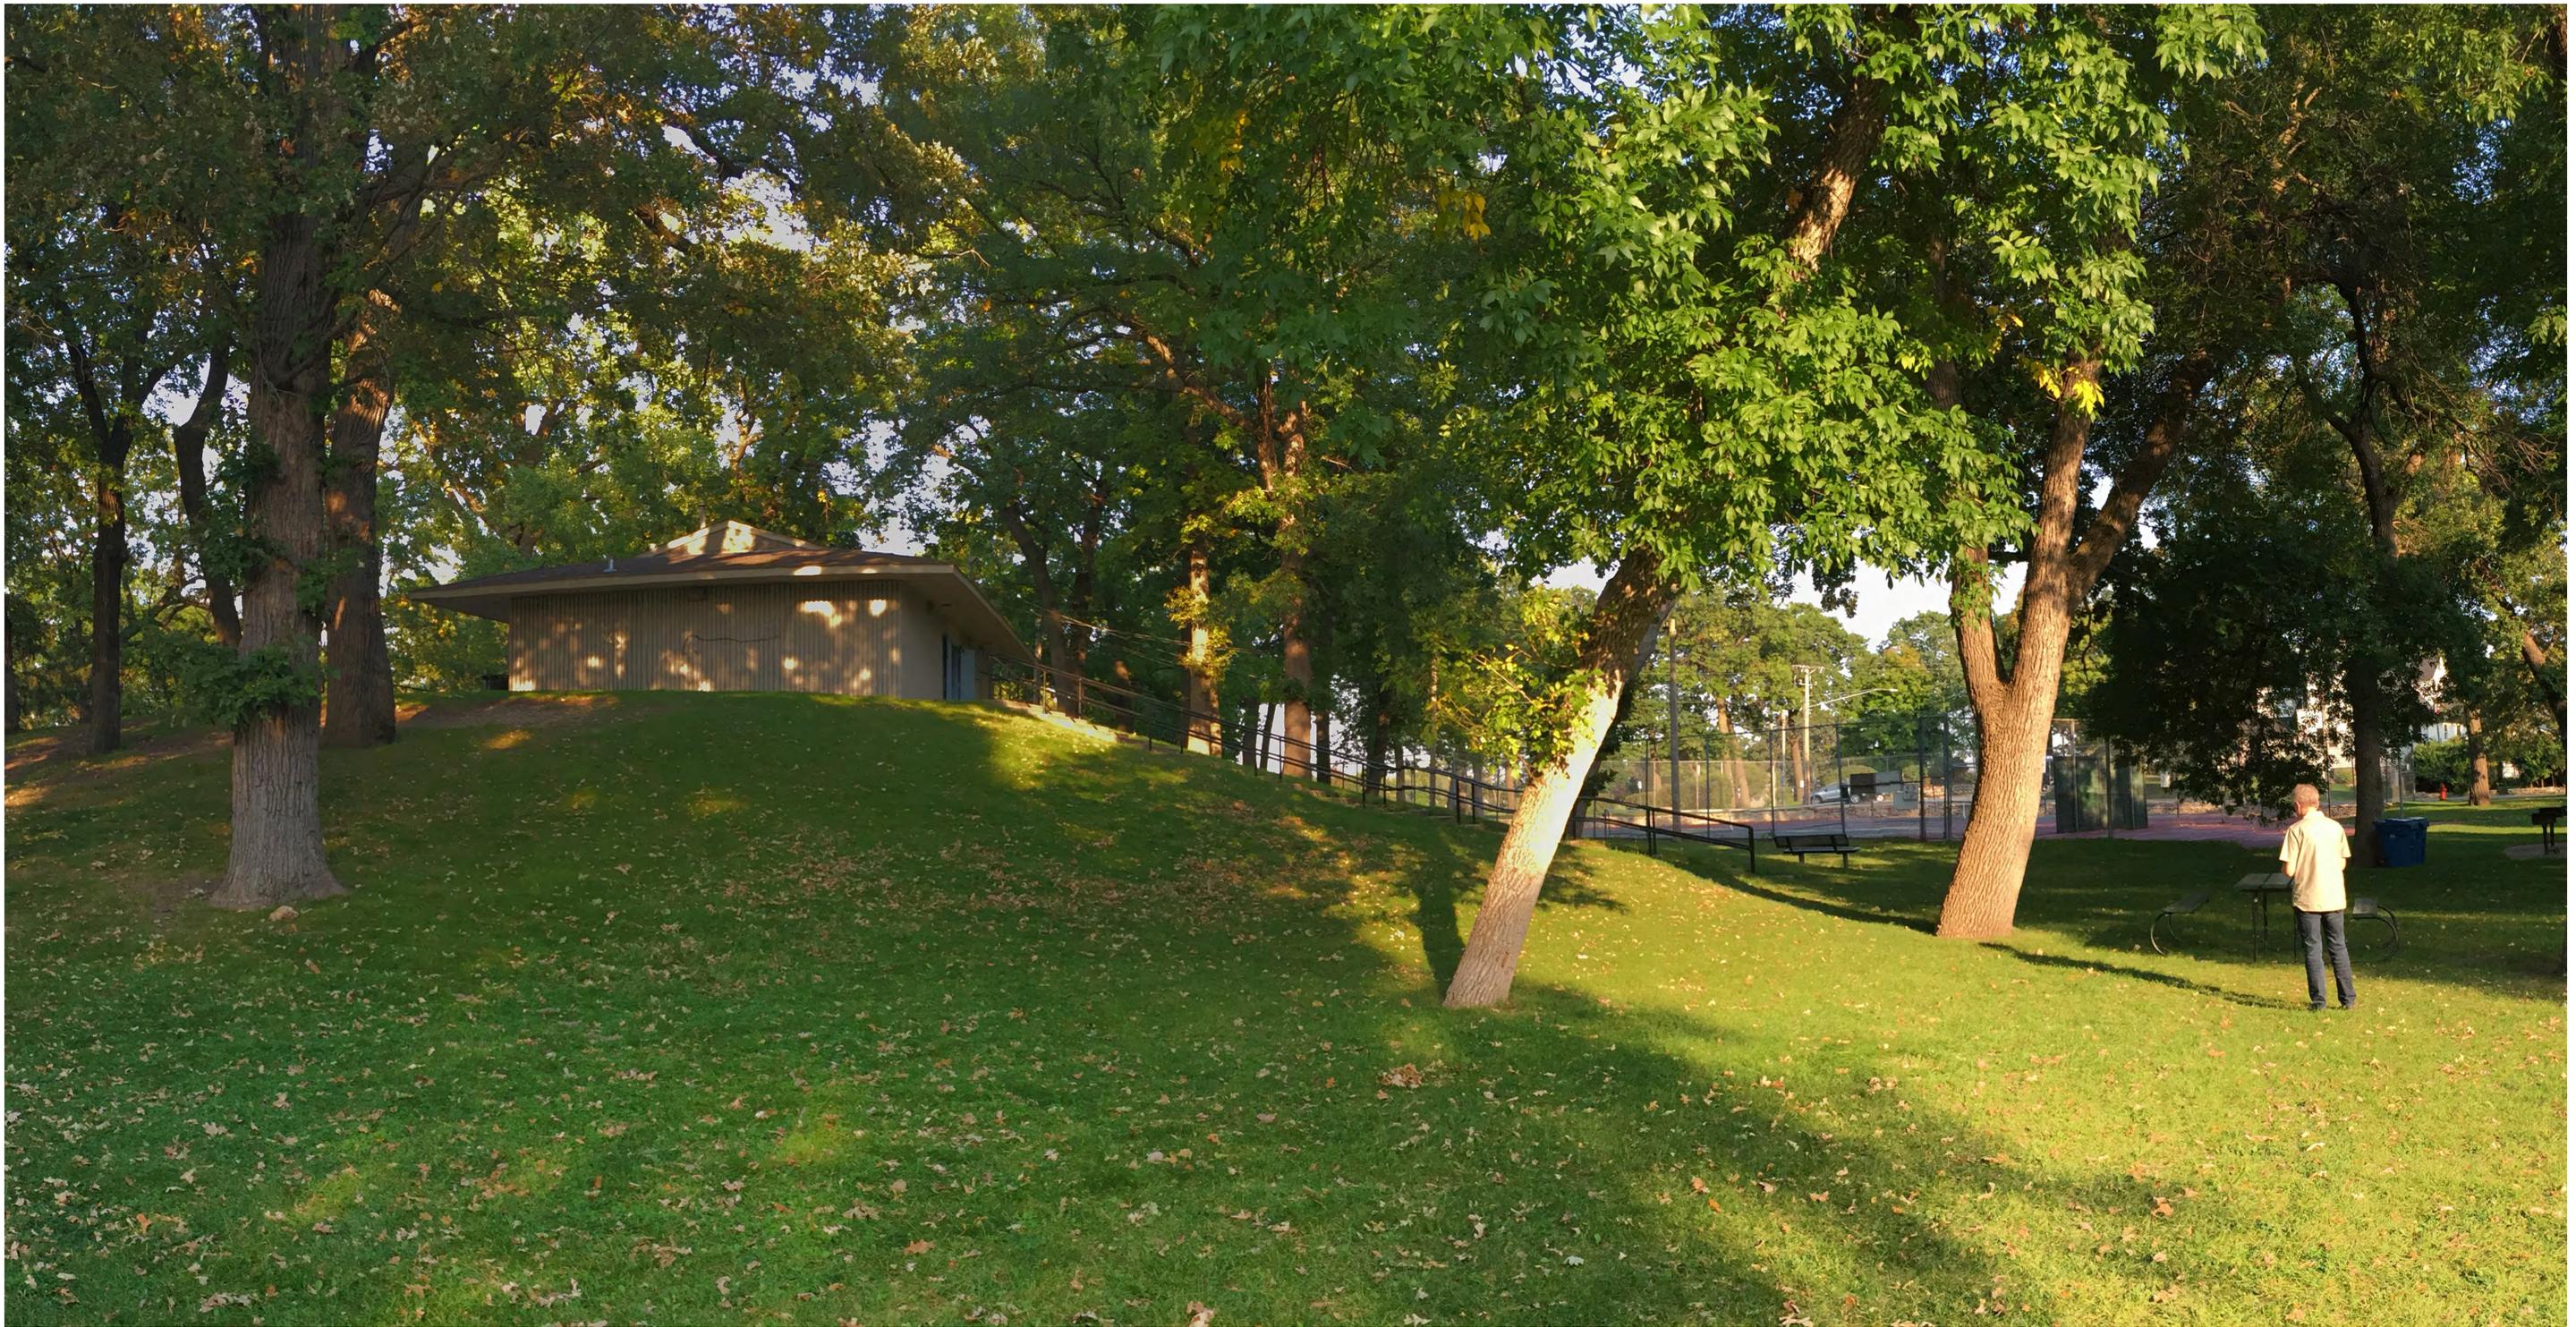
This view is taken from the existing roundabout illustrating the difficult access to the existing restroom/changing building, erosion on the hillside and the one dimensional use of the existing court area.

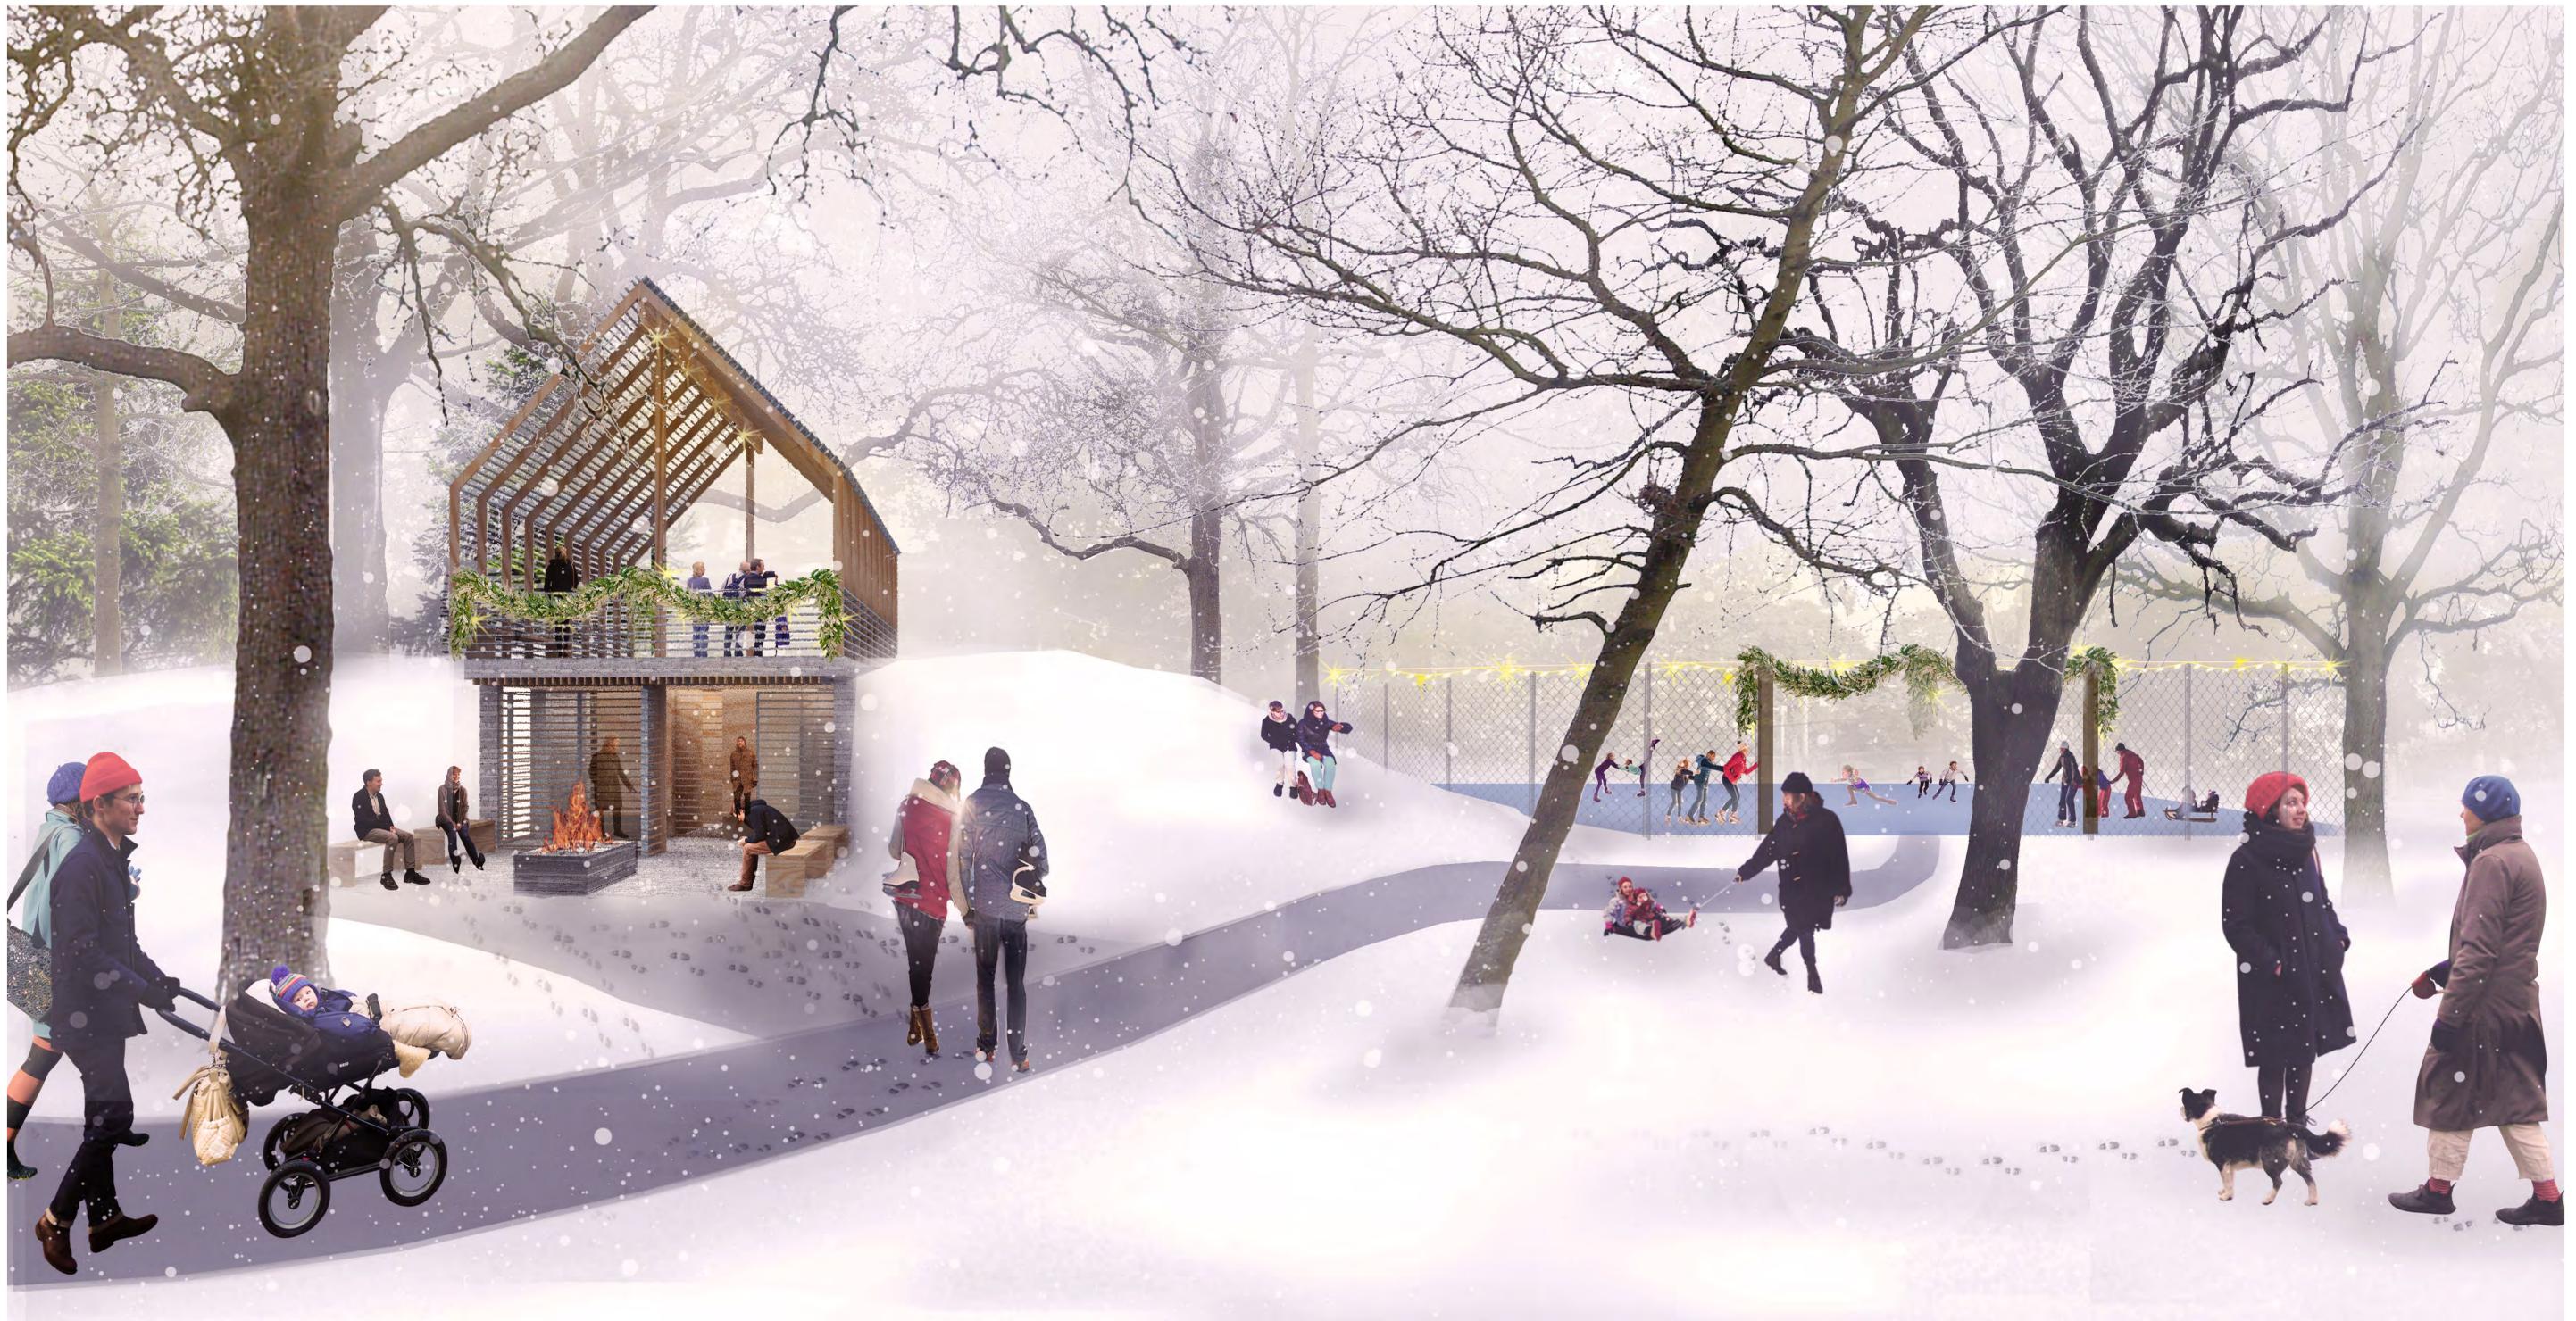
This illustration reflects a transformation of this area into a community winter destination with improved access to the restroom/warming house, outdoor fire pit, direct access to a winter skating area on the courts and the family picnic pavilion on top of the restroom building.
