LAWN AND BALLFIELD AREA EXISTING CONDITIONS

LAWN AND BALLFIELD AREA IMPROVEMENTS

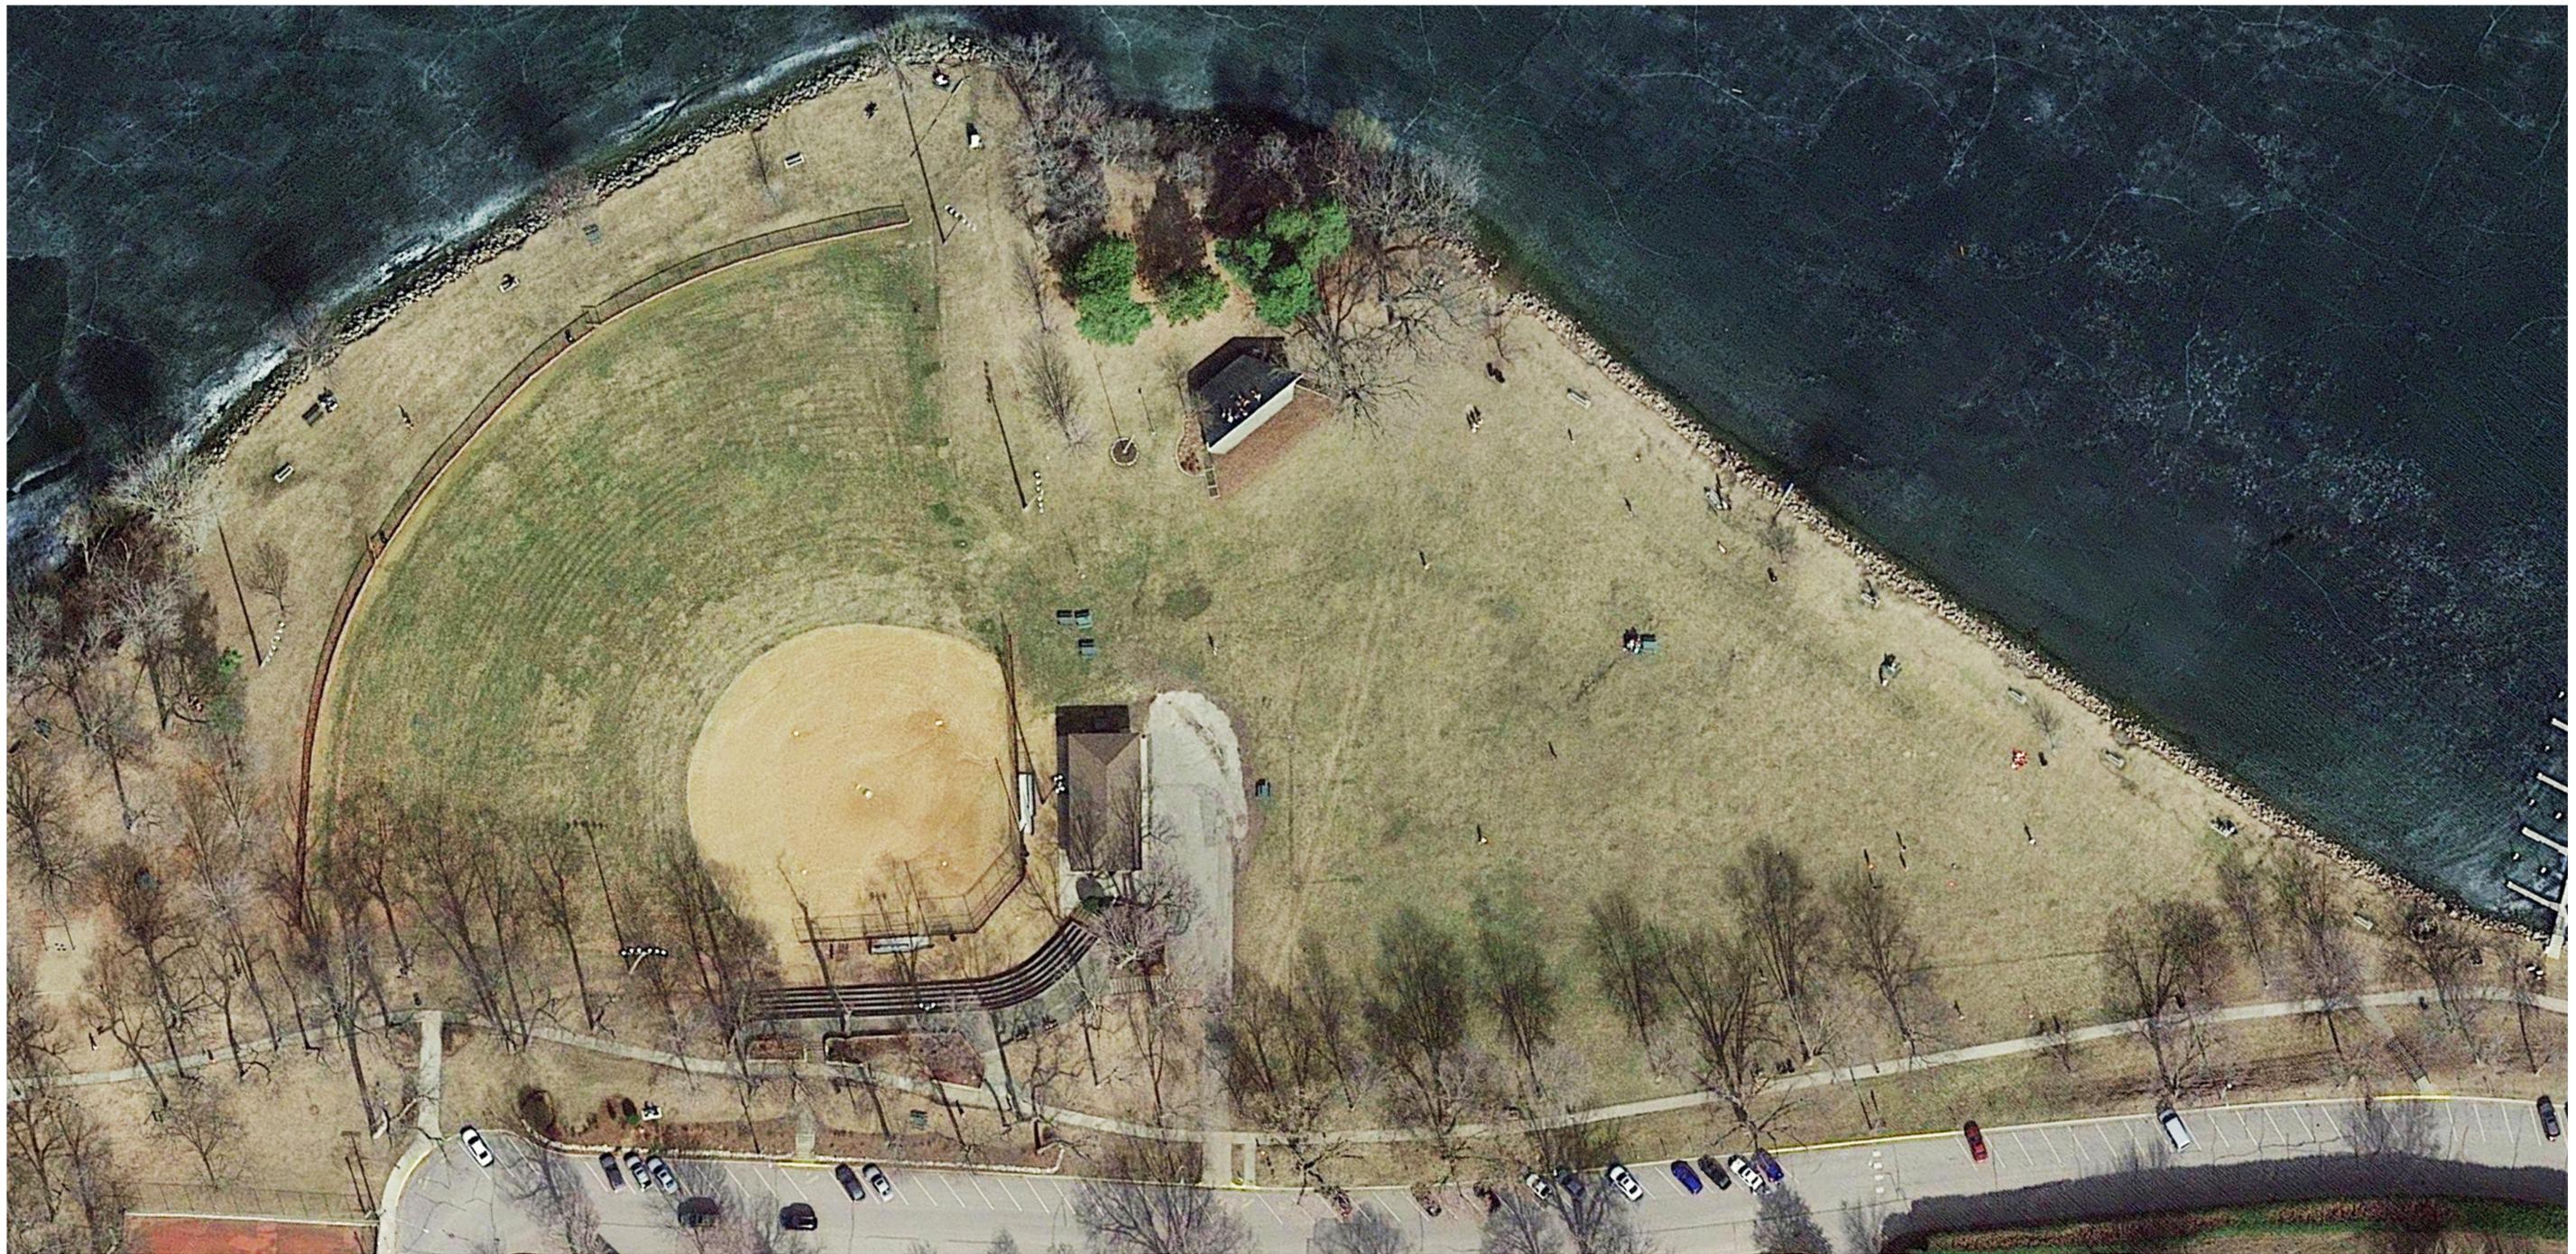
The historic ballfield and Lawn area provide significant recreational benefits and flexibility for community gathering in The Commons. Two significant knolls on either side of the ballfield frame views of the Lake. The existing shoreline offers picturesque views of the Lake. The band shell and concession/restroom structure are in disrepair and is in need of updating. The following additional issues were identified as areas for improvement:

- Ballfield requires grading and drainage improvements
- Challenging access to the lake edge
- Shoreline erosion
- Bandshell could be replaced for multi-purpose use
- Challenging access from neighborhood to park
- Concession stand and restroom facility is obsolete
- Tree canopy on knolls require maintenance
- Unmanaged run-off into the lake

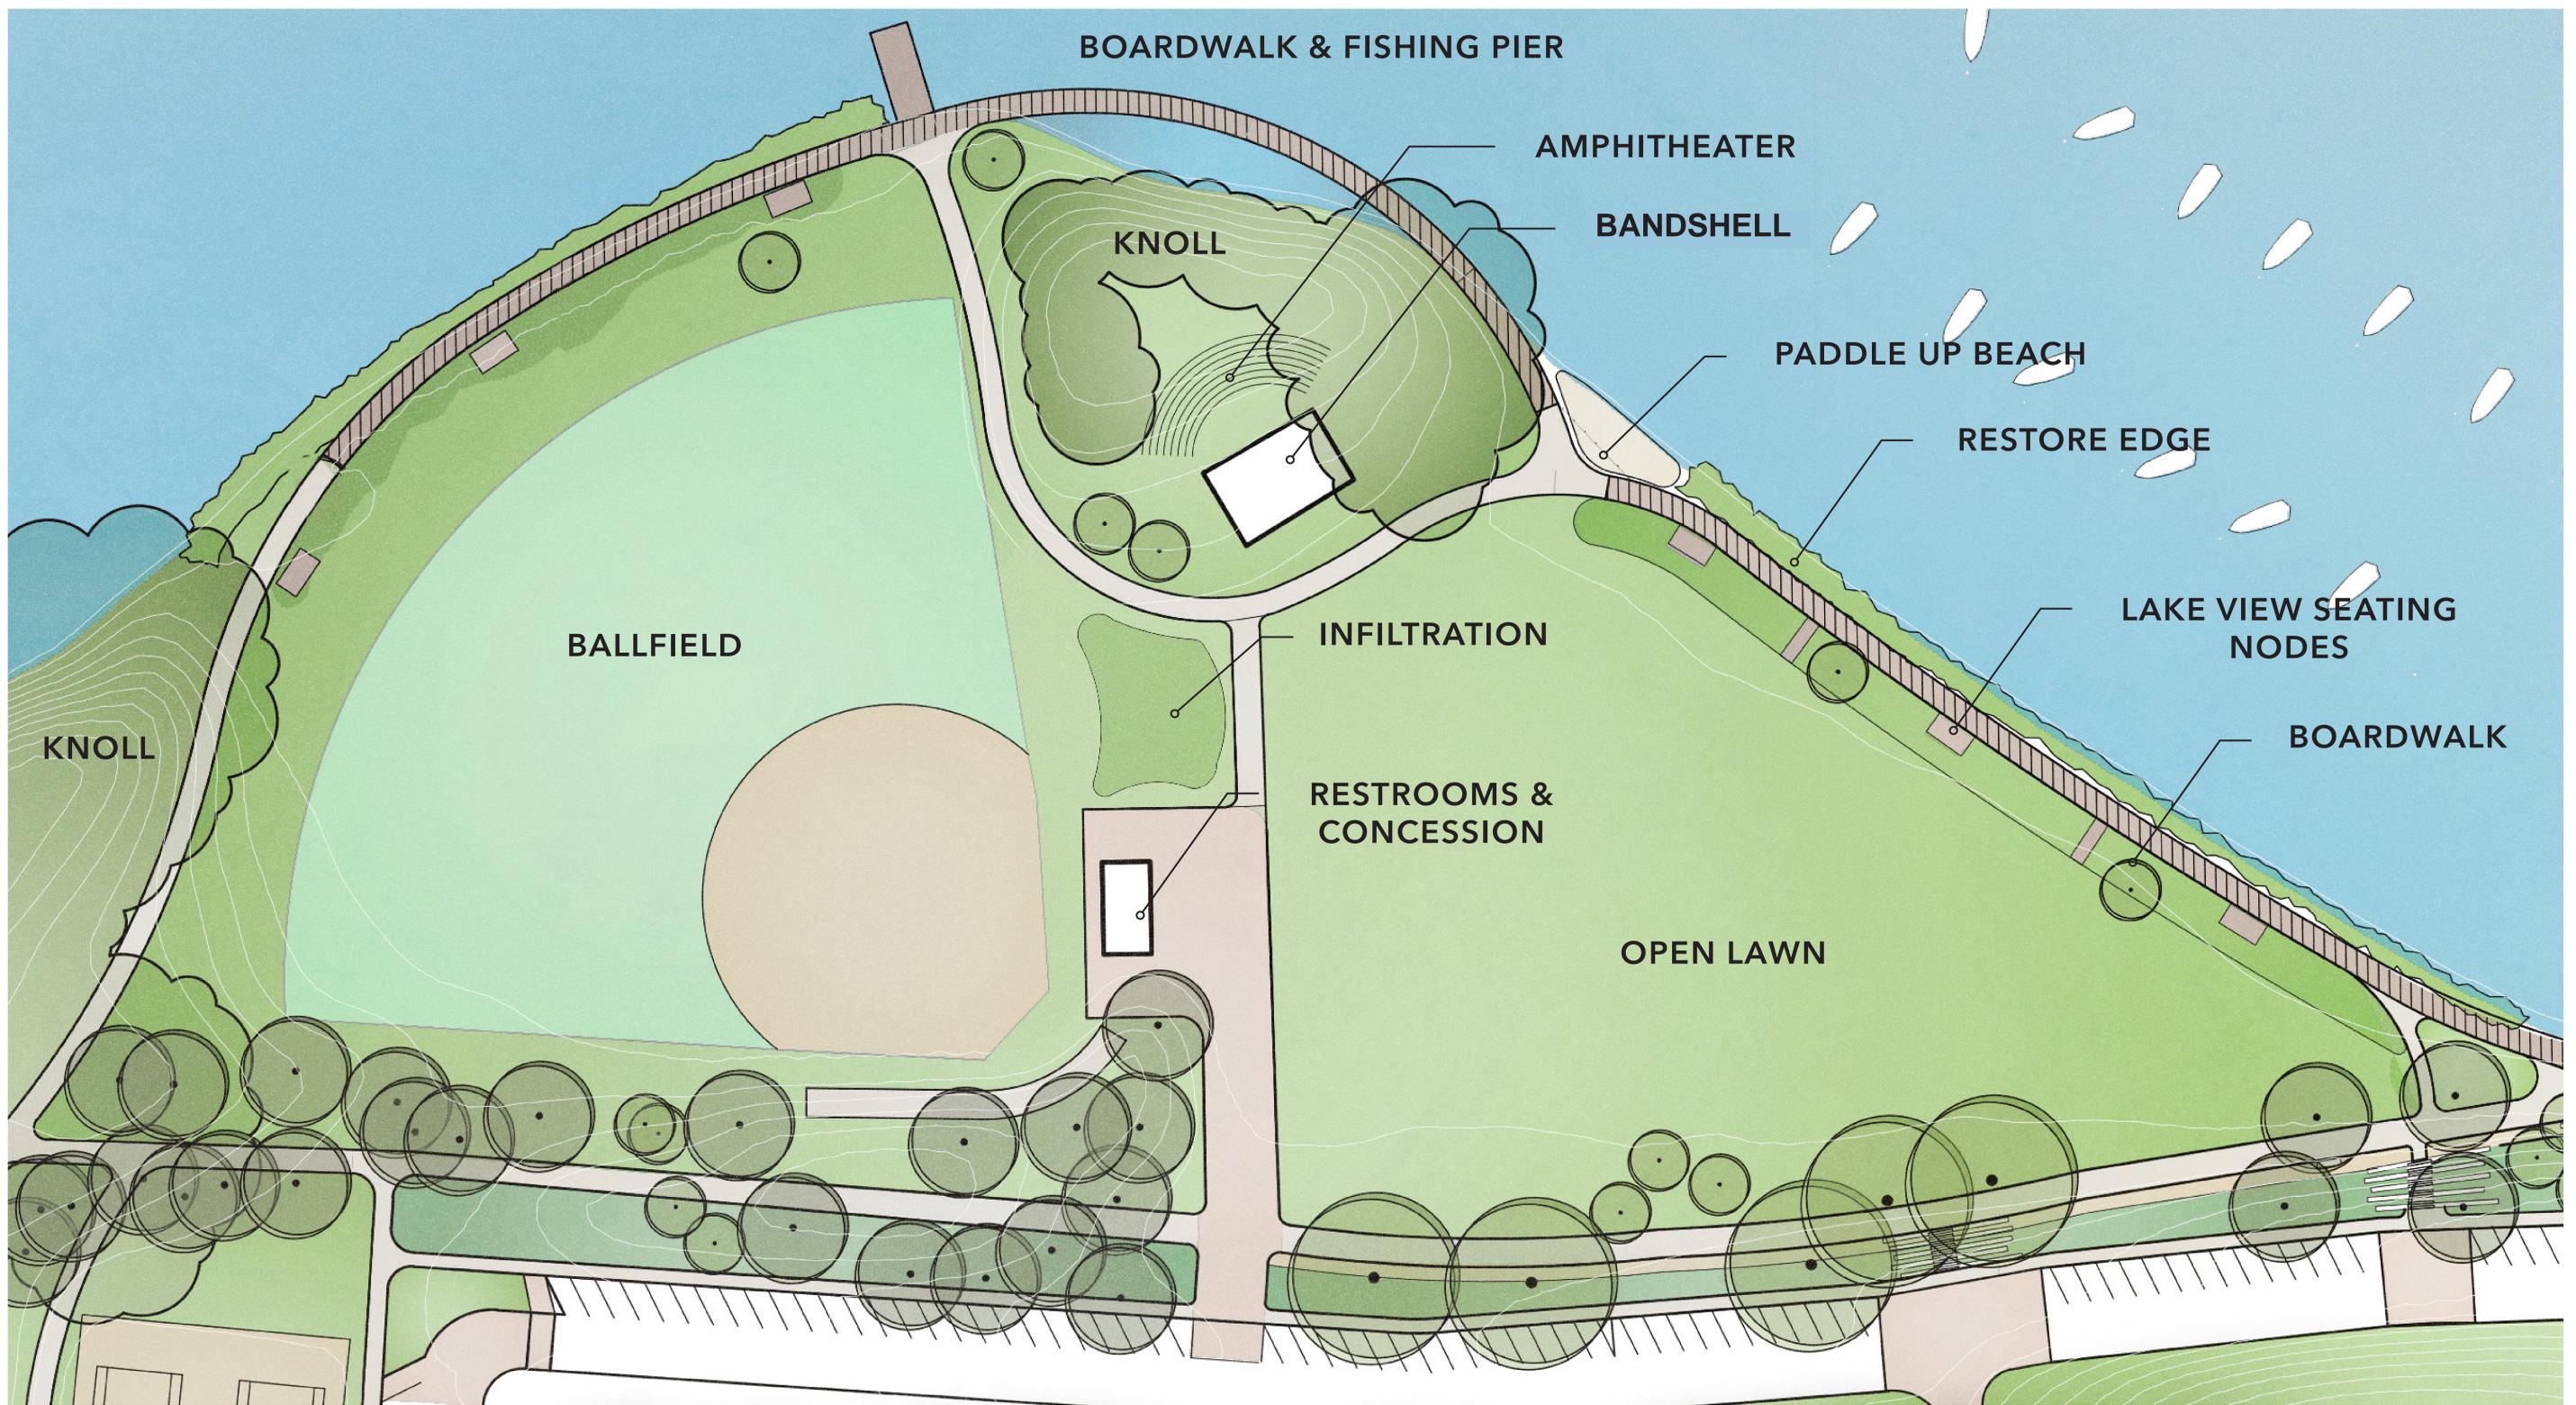
Recommendations – The master plan recommends maintaining the current uses of this area but improving the overall supporting infrastructure to facilitate that use. Ecological, circulation and facility improvements in this area will enhance use while maintaining the current character. Proposed improvements include:

- Shoreline fortification and restoration
- Perimeter loop trail and boardwalk
- Multi-functional, bidirectional, bandshell with seating on the knoll
- Infiltration basins to filter runoff prior to discharge into the Lake
- New concession and restroom building that serves events on ballfield and open lawn area
- Enhanced neighborhood entries across Lake Street
- Refurbish ballfield
- Invasive species removal on knolls
- Preservation of existing tree canopy
- Fishing pier
- Enhanced lighting, minimizing light pollution and glare

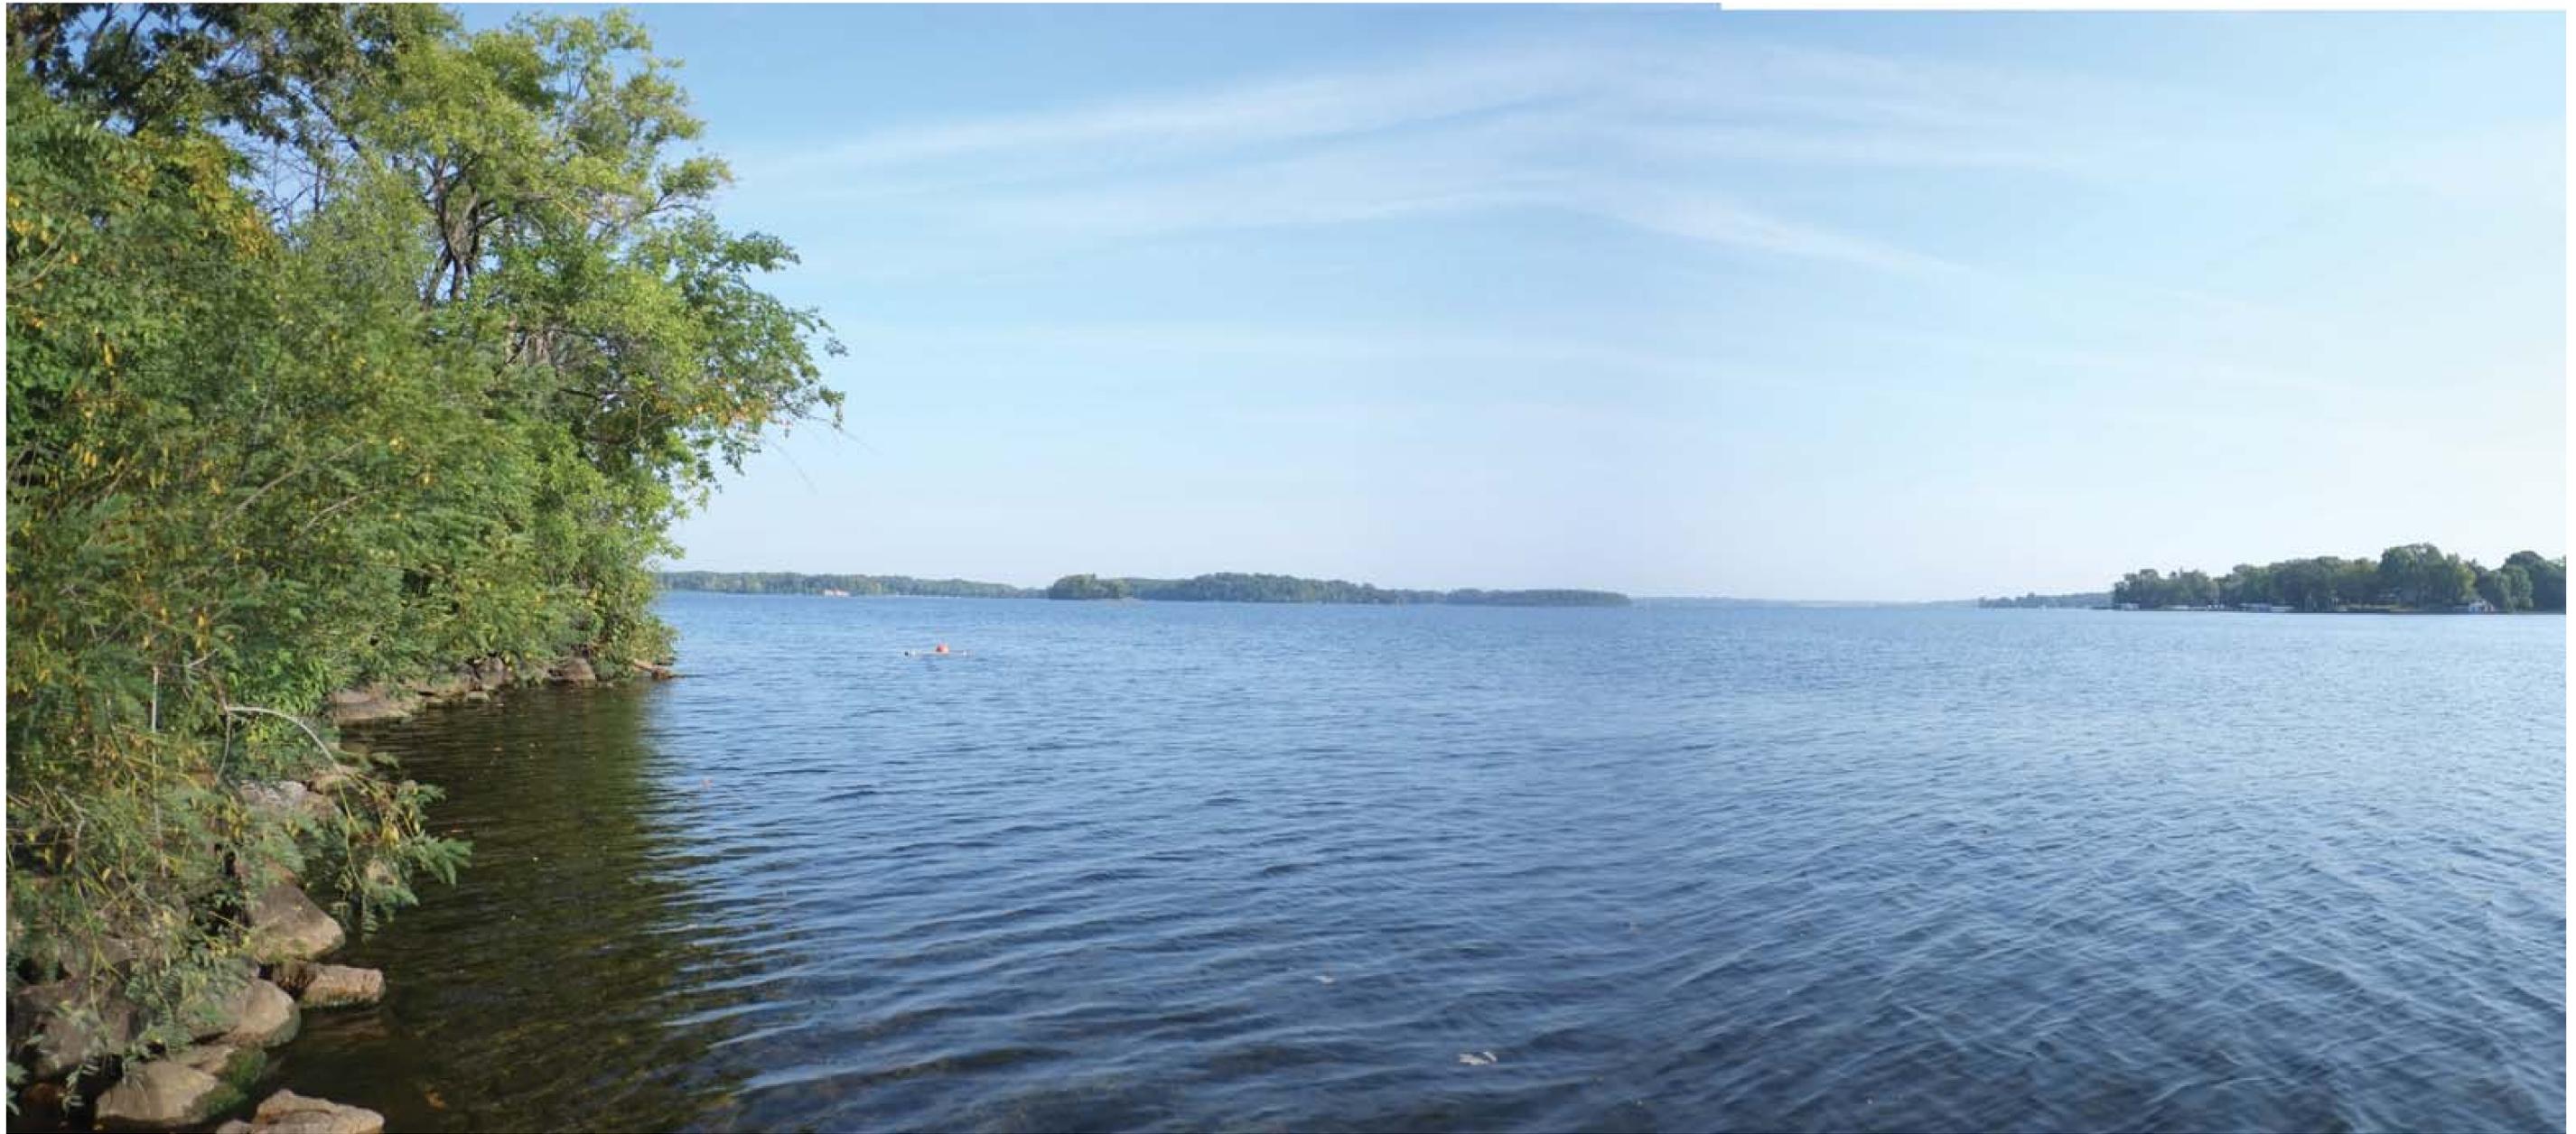
LAWN AND BALLFIELD AREA EXISTING

The knoll provides picturesque views of Lake Minnetonka, but views are obstructed due to the presence of invasive species.

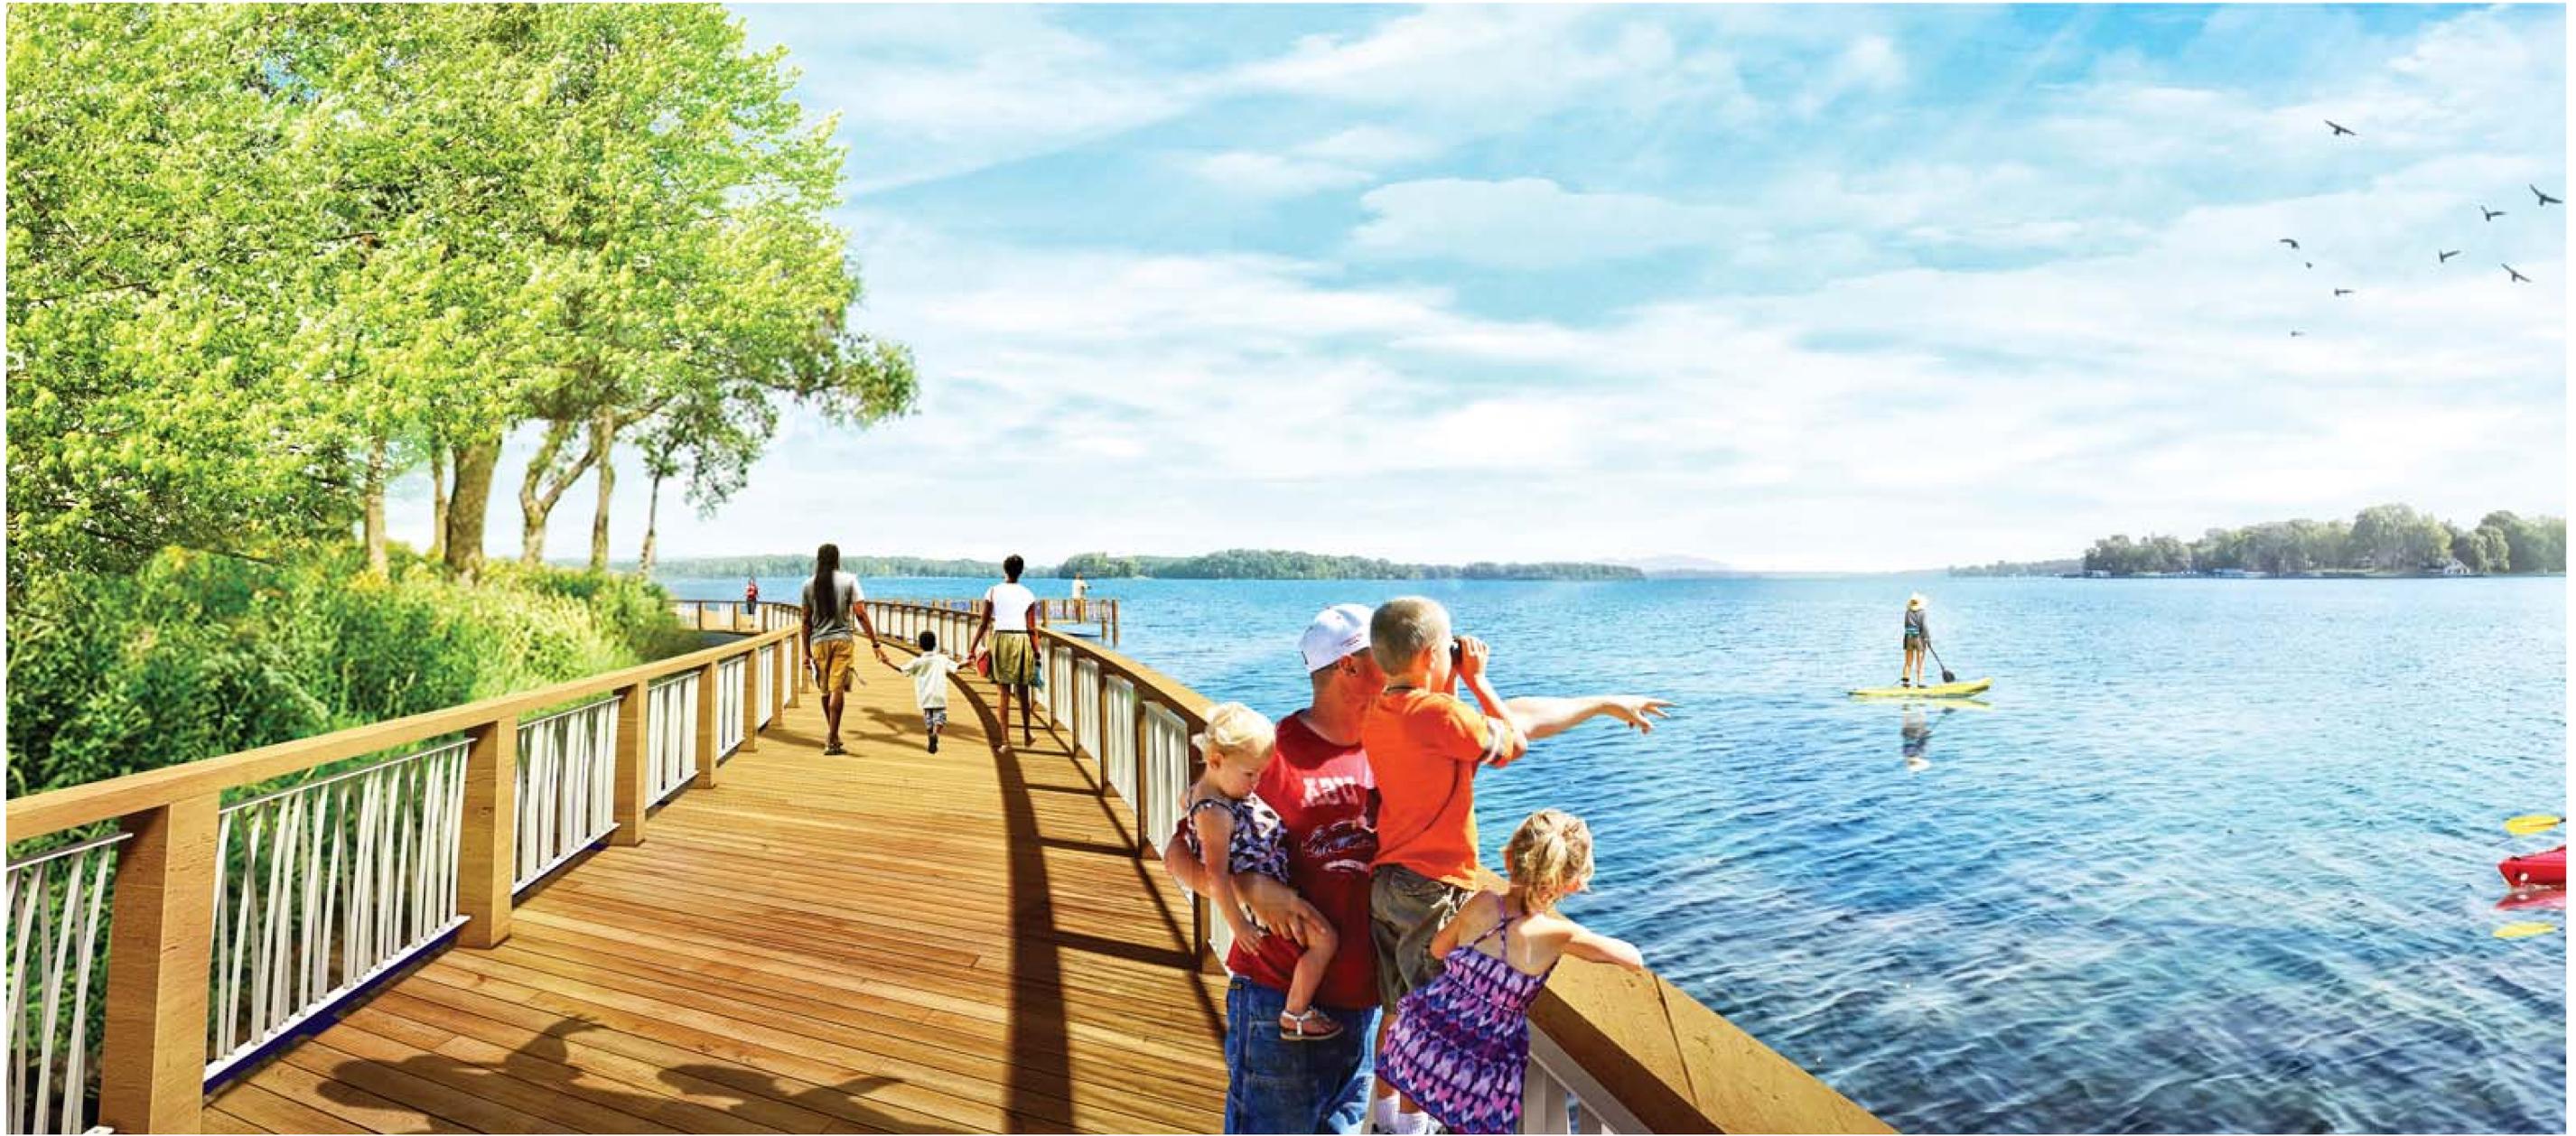
LAWN AND BALLFIELD AREA IMPROVEMENTS

The creation of a loop boardwalk on the backside of the existing knoll allows for a continuous perimeter walk within The Commons and claims area that is currently not used. The boardwalk also connects to a fishing pier (seen in the distance) that provides new recreational opportunities. Invasive species have been removed on the knoll to open up views to the Lake and the boardwalk.

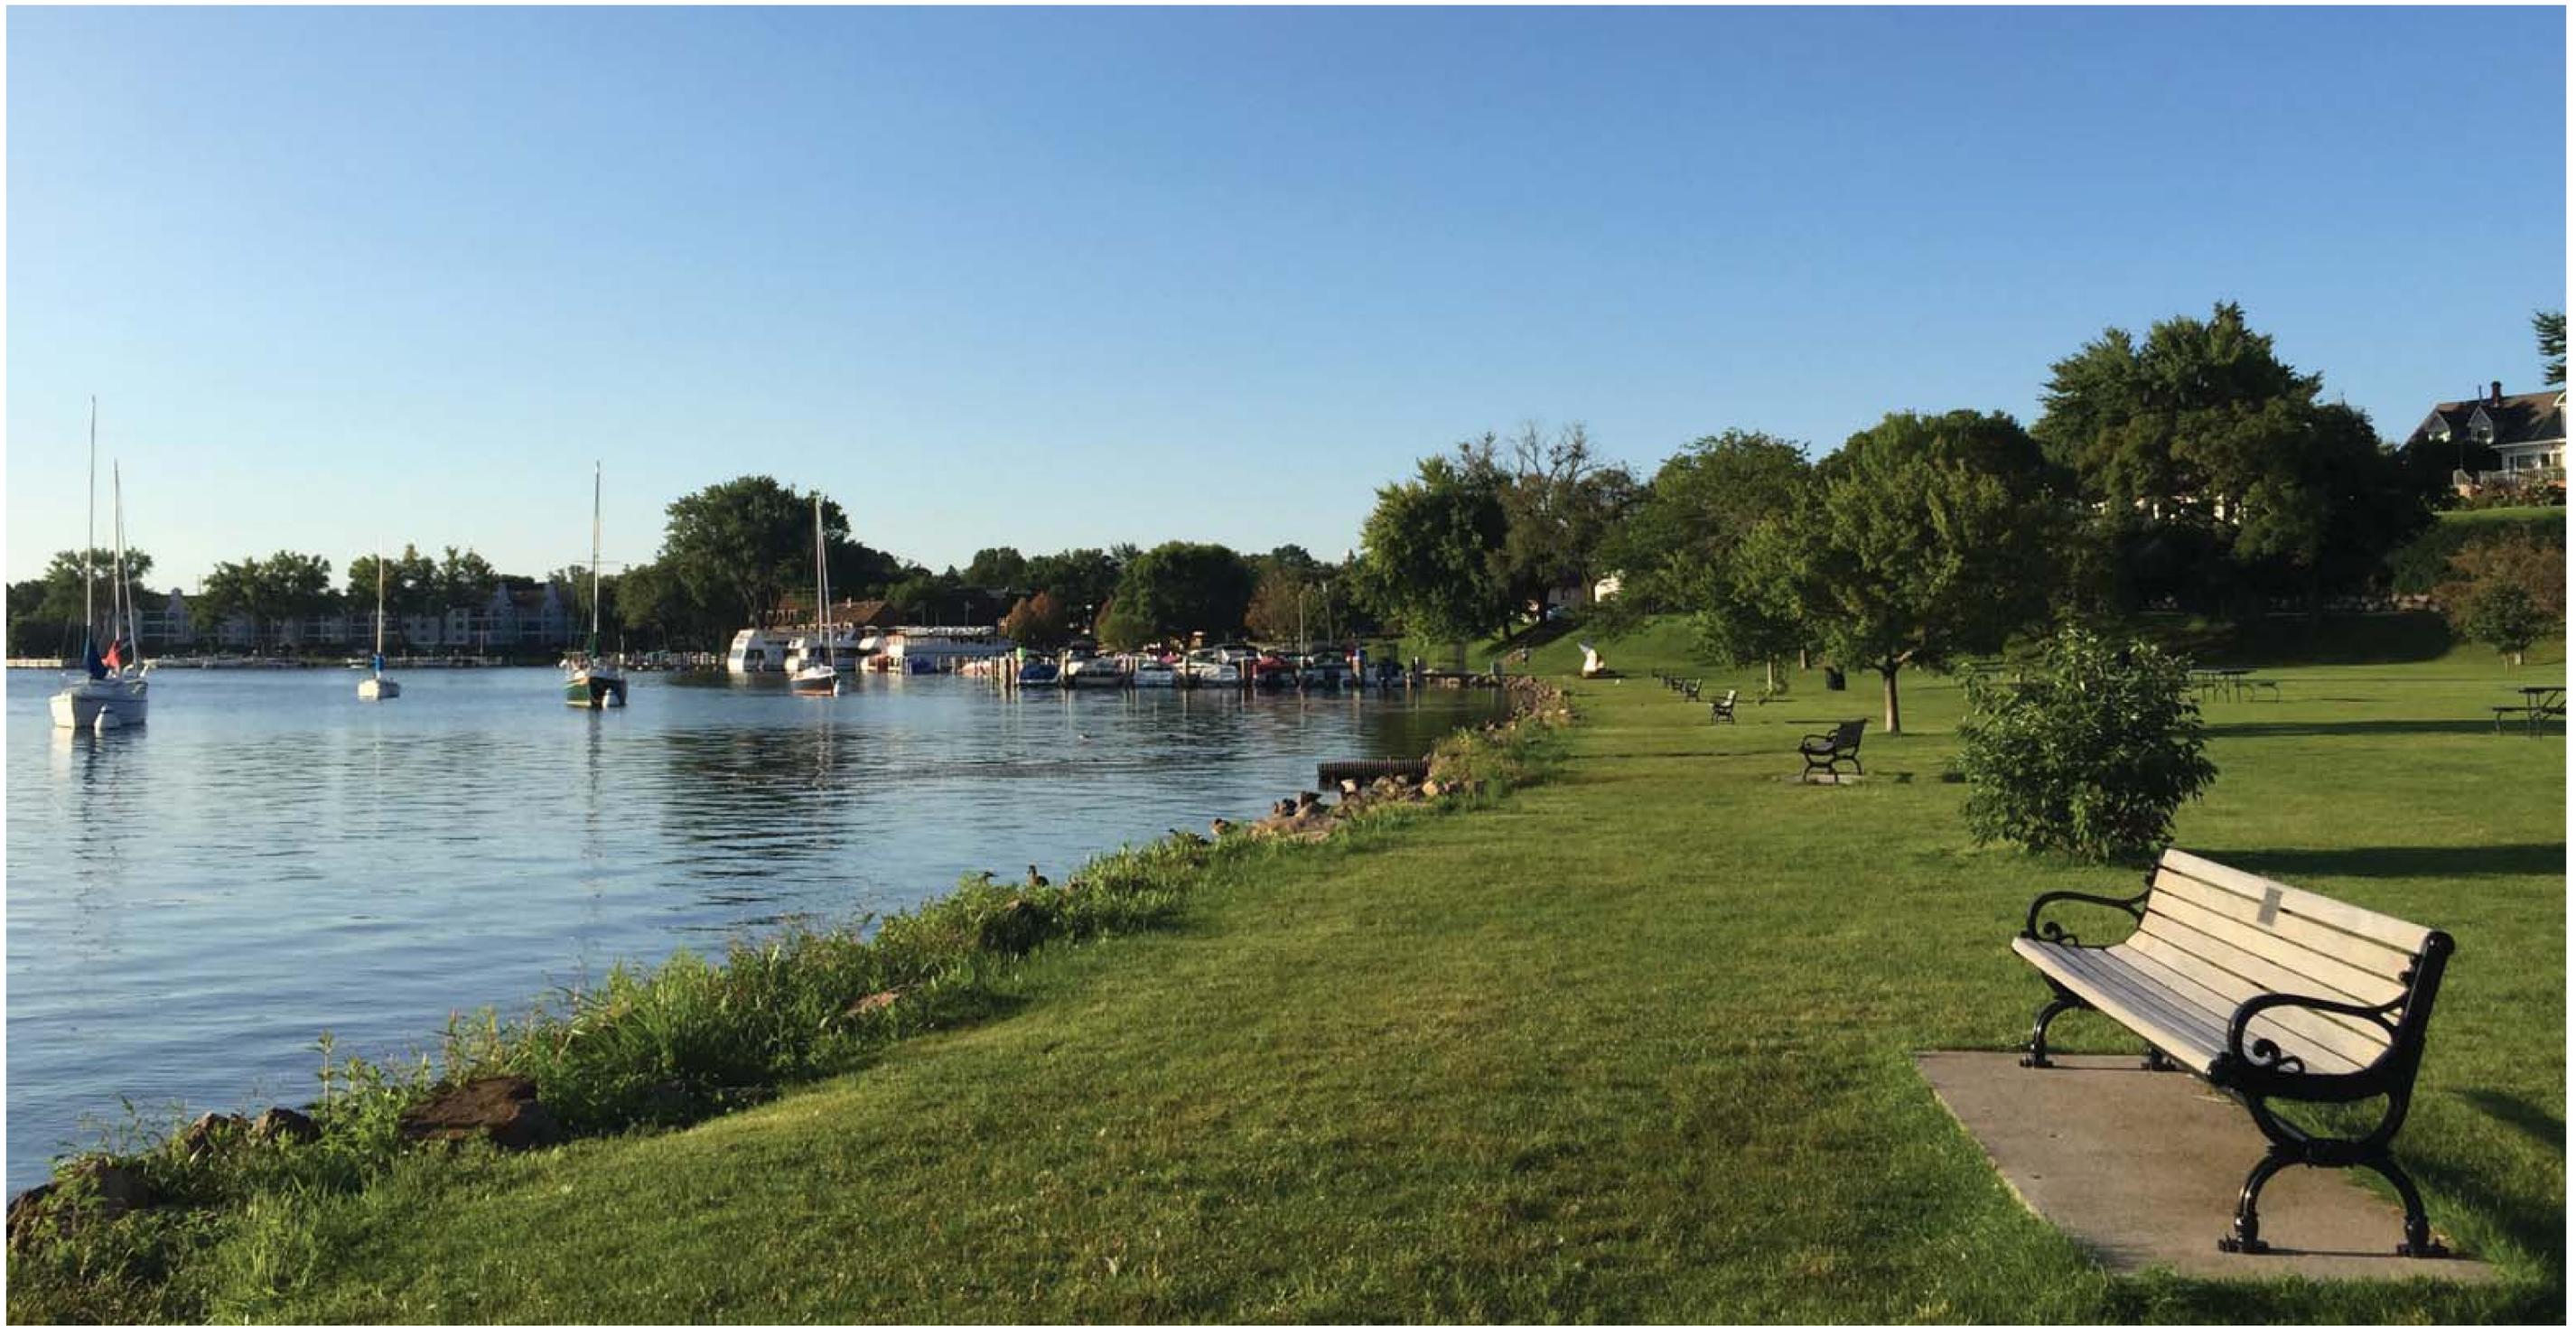
LAWN AND BALLFIELD AREA **EXISTING**

The current lake edge has seen significant erosion, does not filter runoff water and is not ADA accessible.

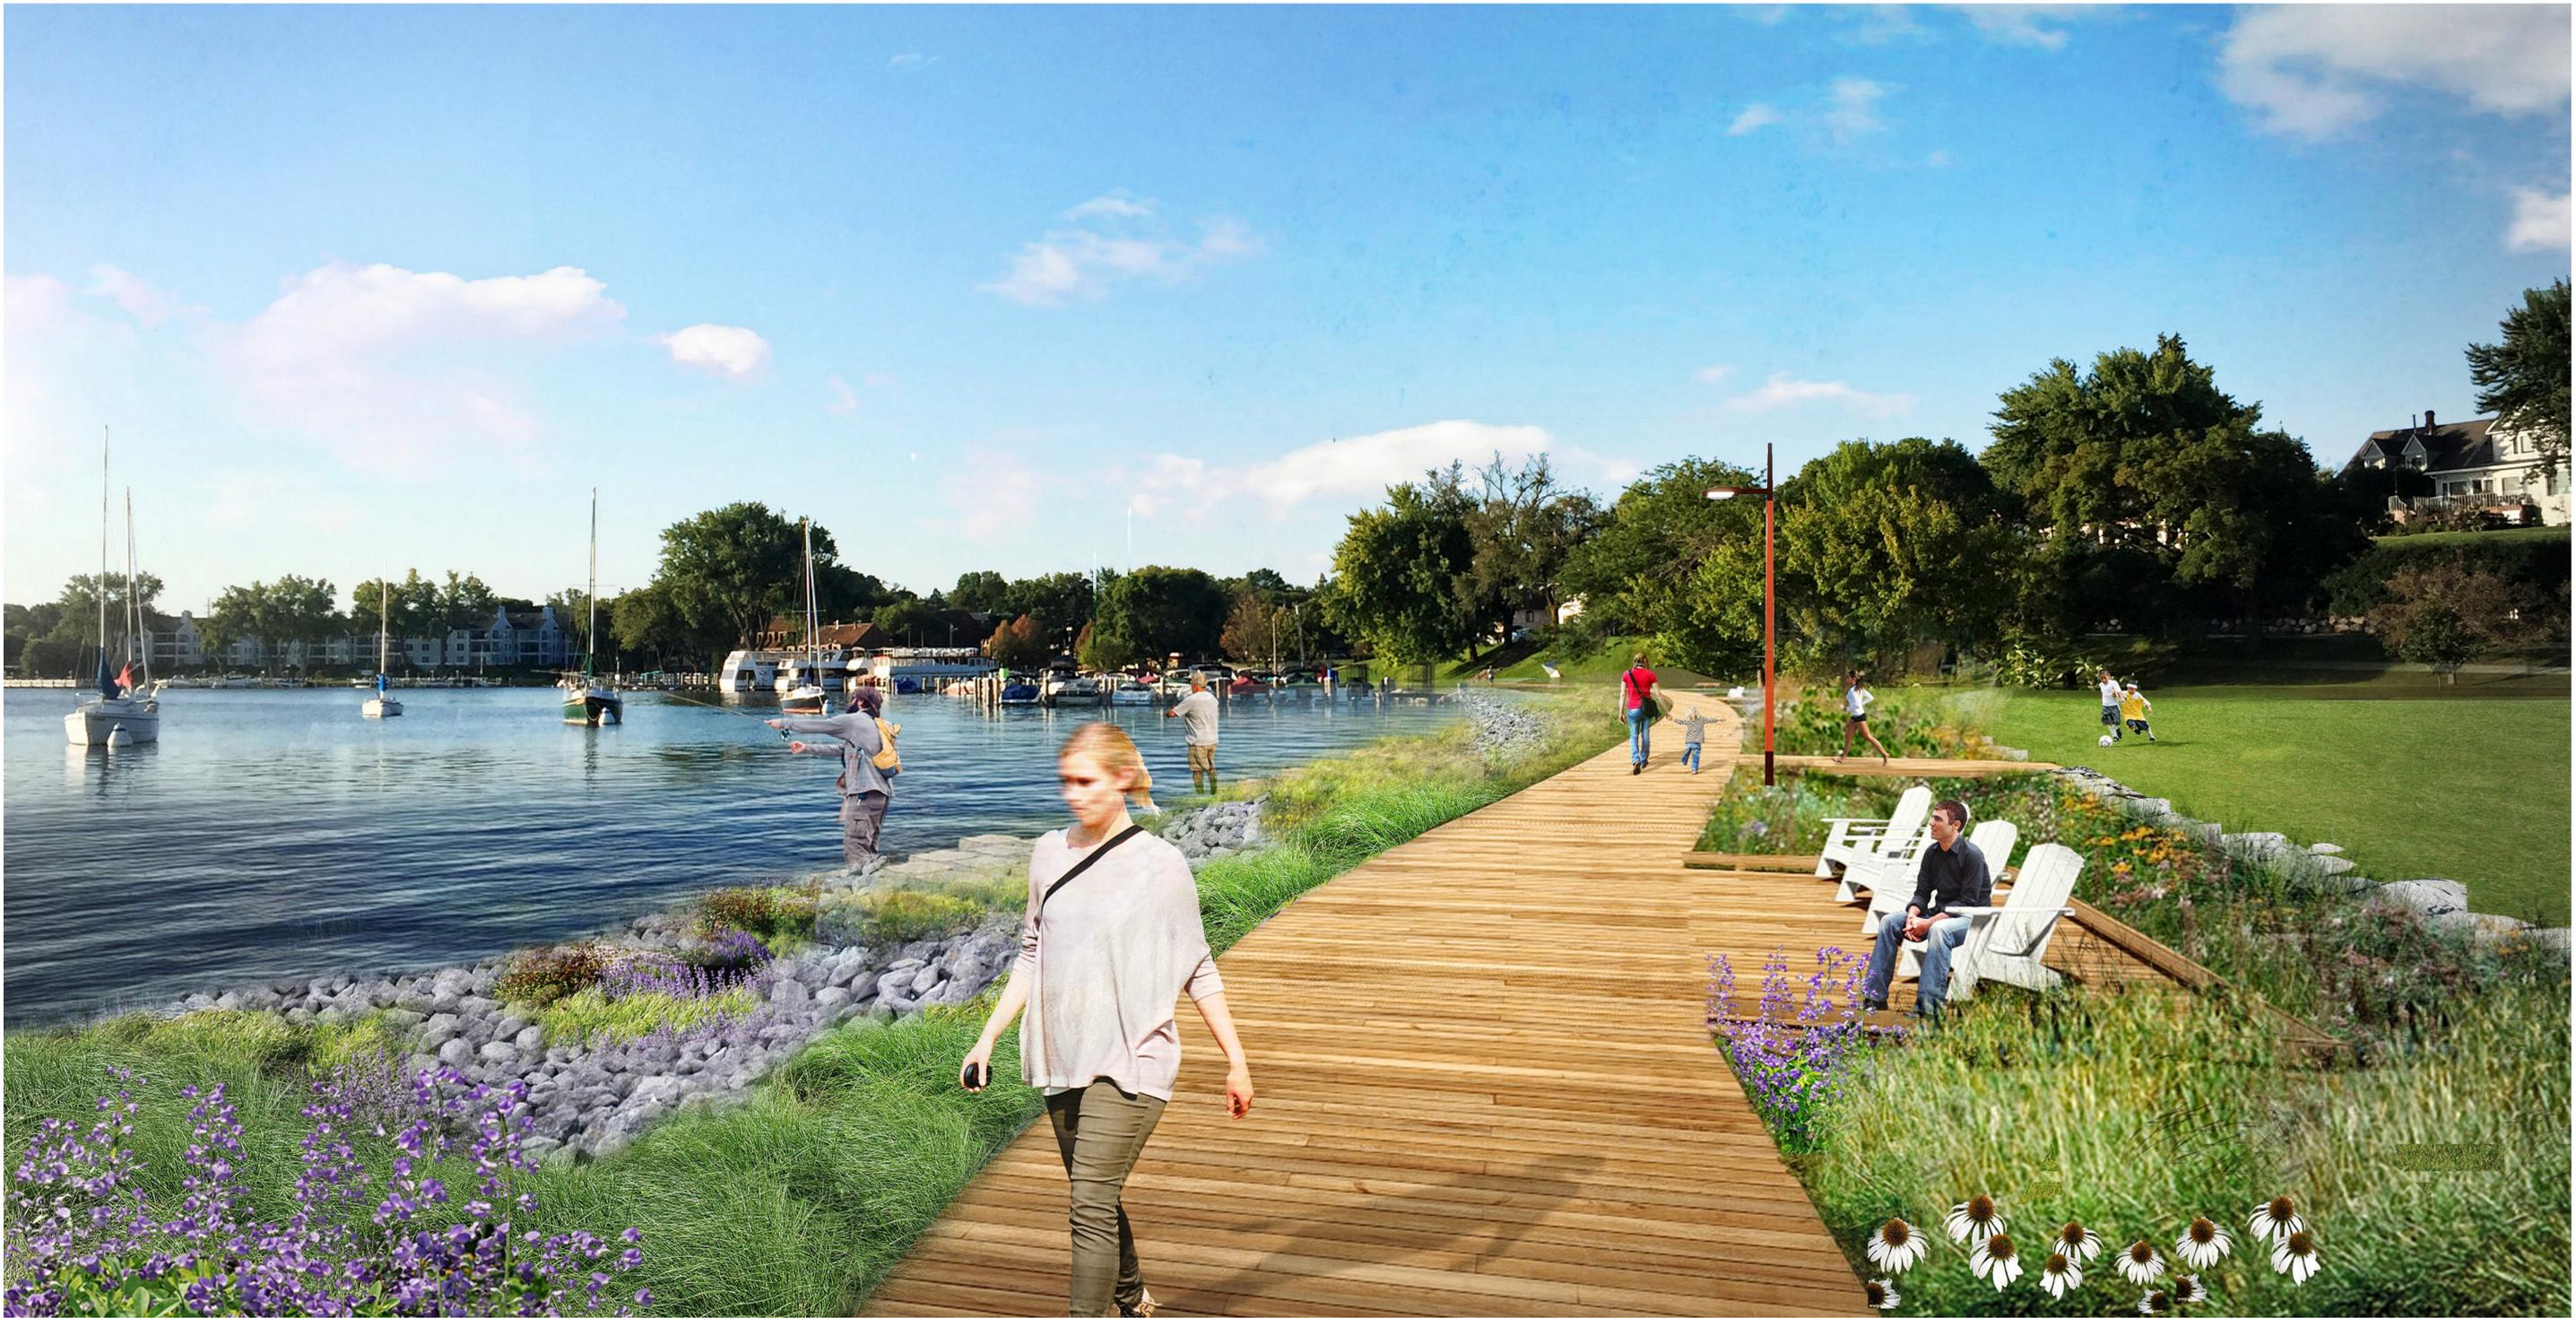
LAWN AND BALLFIELD AREA IMPROVEMENTS

SHORELINE RESTORATION

BOARDWALK

WET MEADOW

The master plan recommends the development of a boardwalk system along the lake edge with gathering areas that promote interaction and conversation. New fortification of the lake edge and the introduction of a buffer infiltration area on both sides of the walk will create an immersive experience that promotes improved ecological function of The Commons.
