LAWN AND BALLFIELD AREA EXISTING CONDITIONS

LAWN AND BALLFIELD AREA IMPROVEMENTS

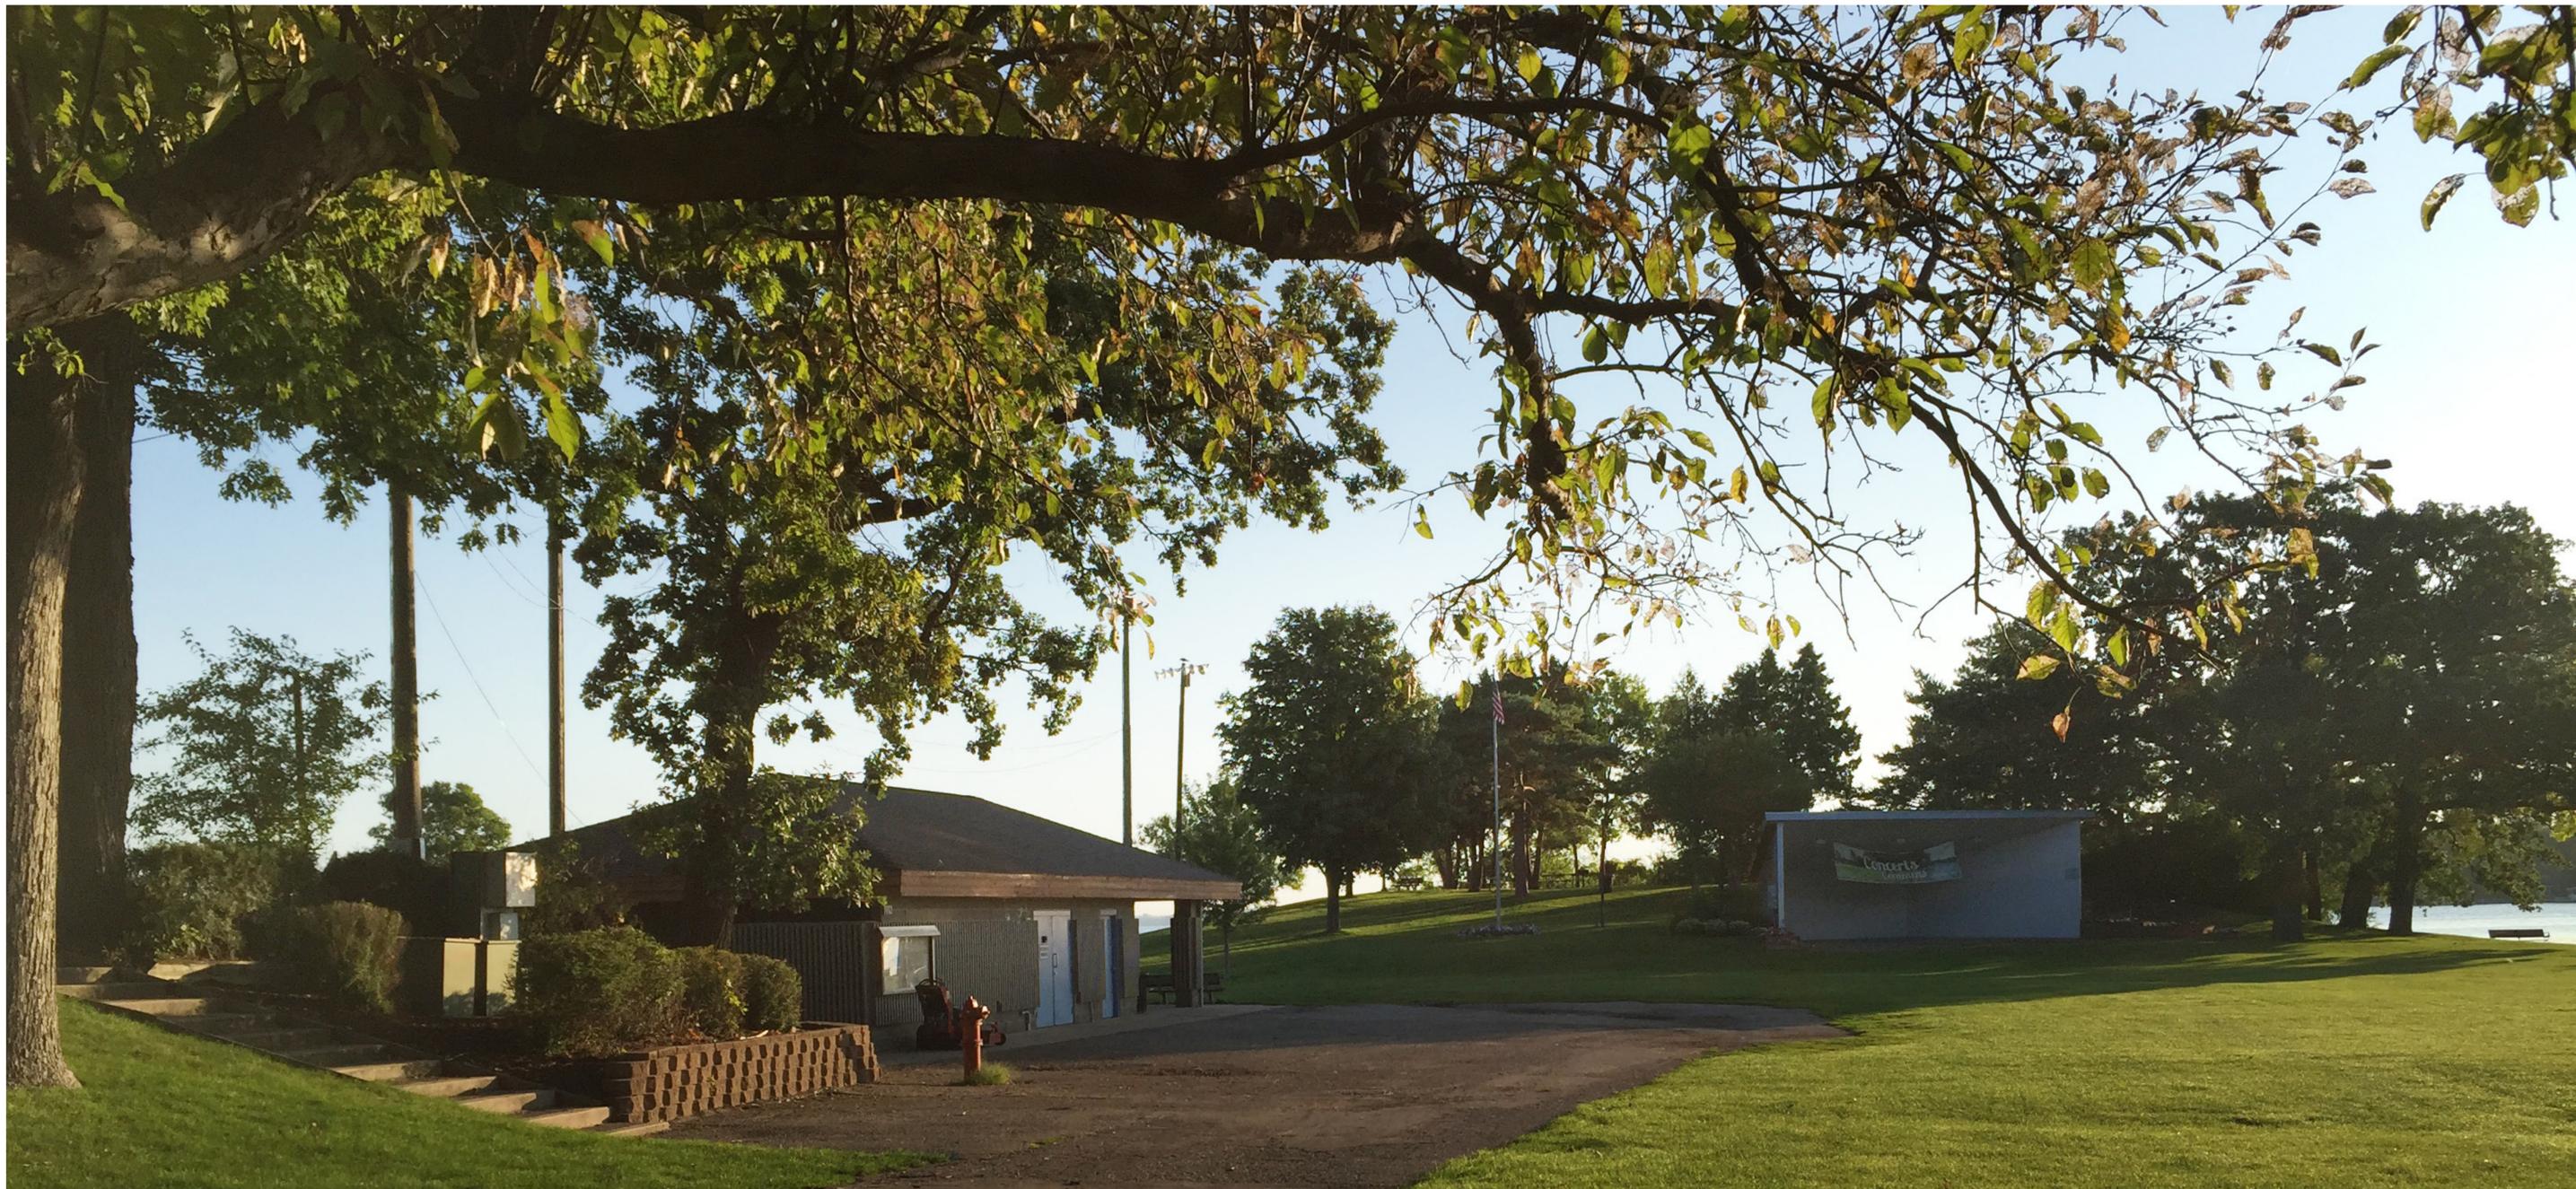
LAWN AND BALLFIELD AREA EXISTING

The current bandshell and concessions buildings are obsolete and do not take advantage of the 360 degree nature of their settings. An opportunity exists to re-envision these structures to better serve the evolving needs of park users.

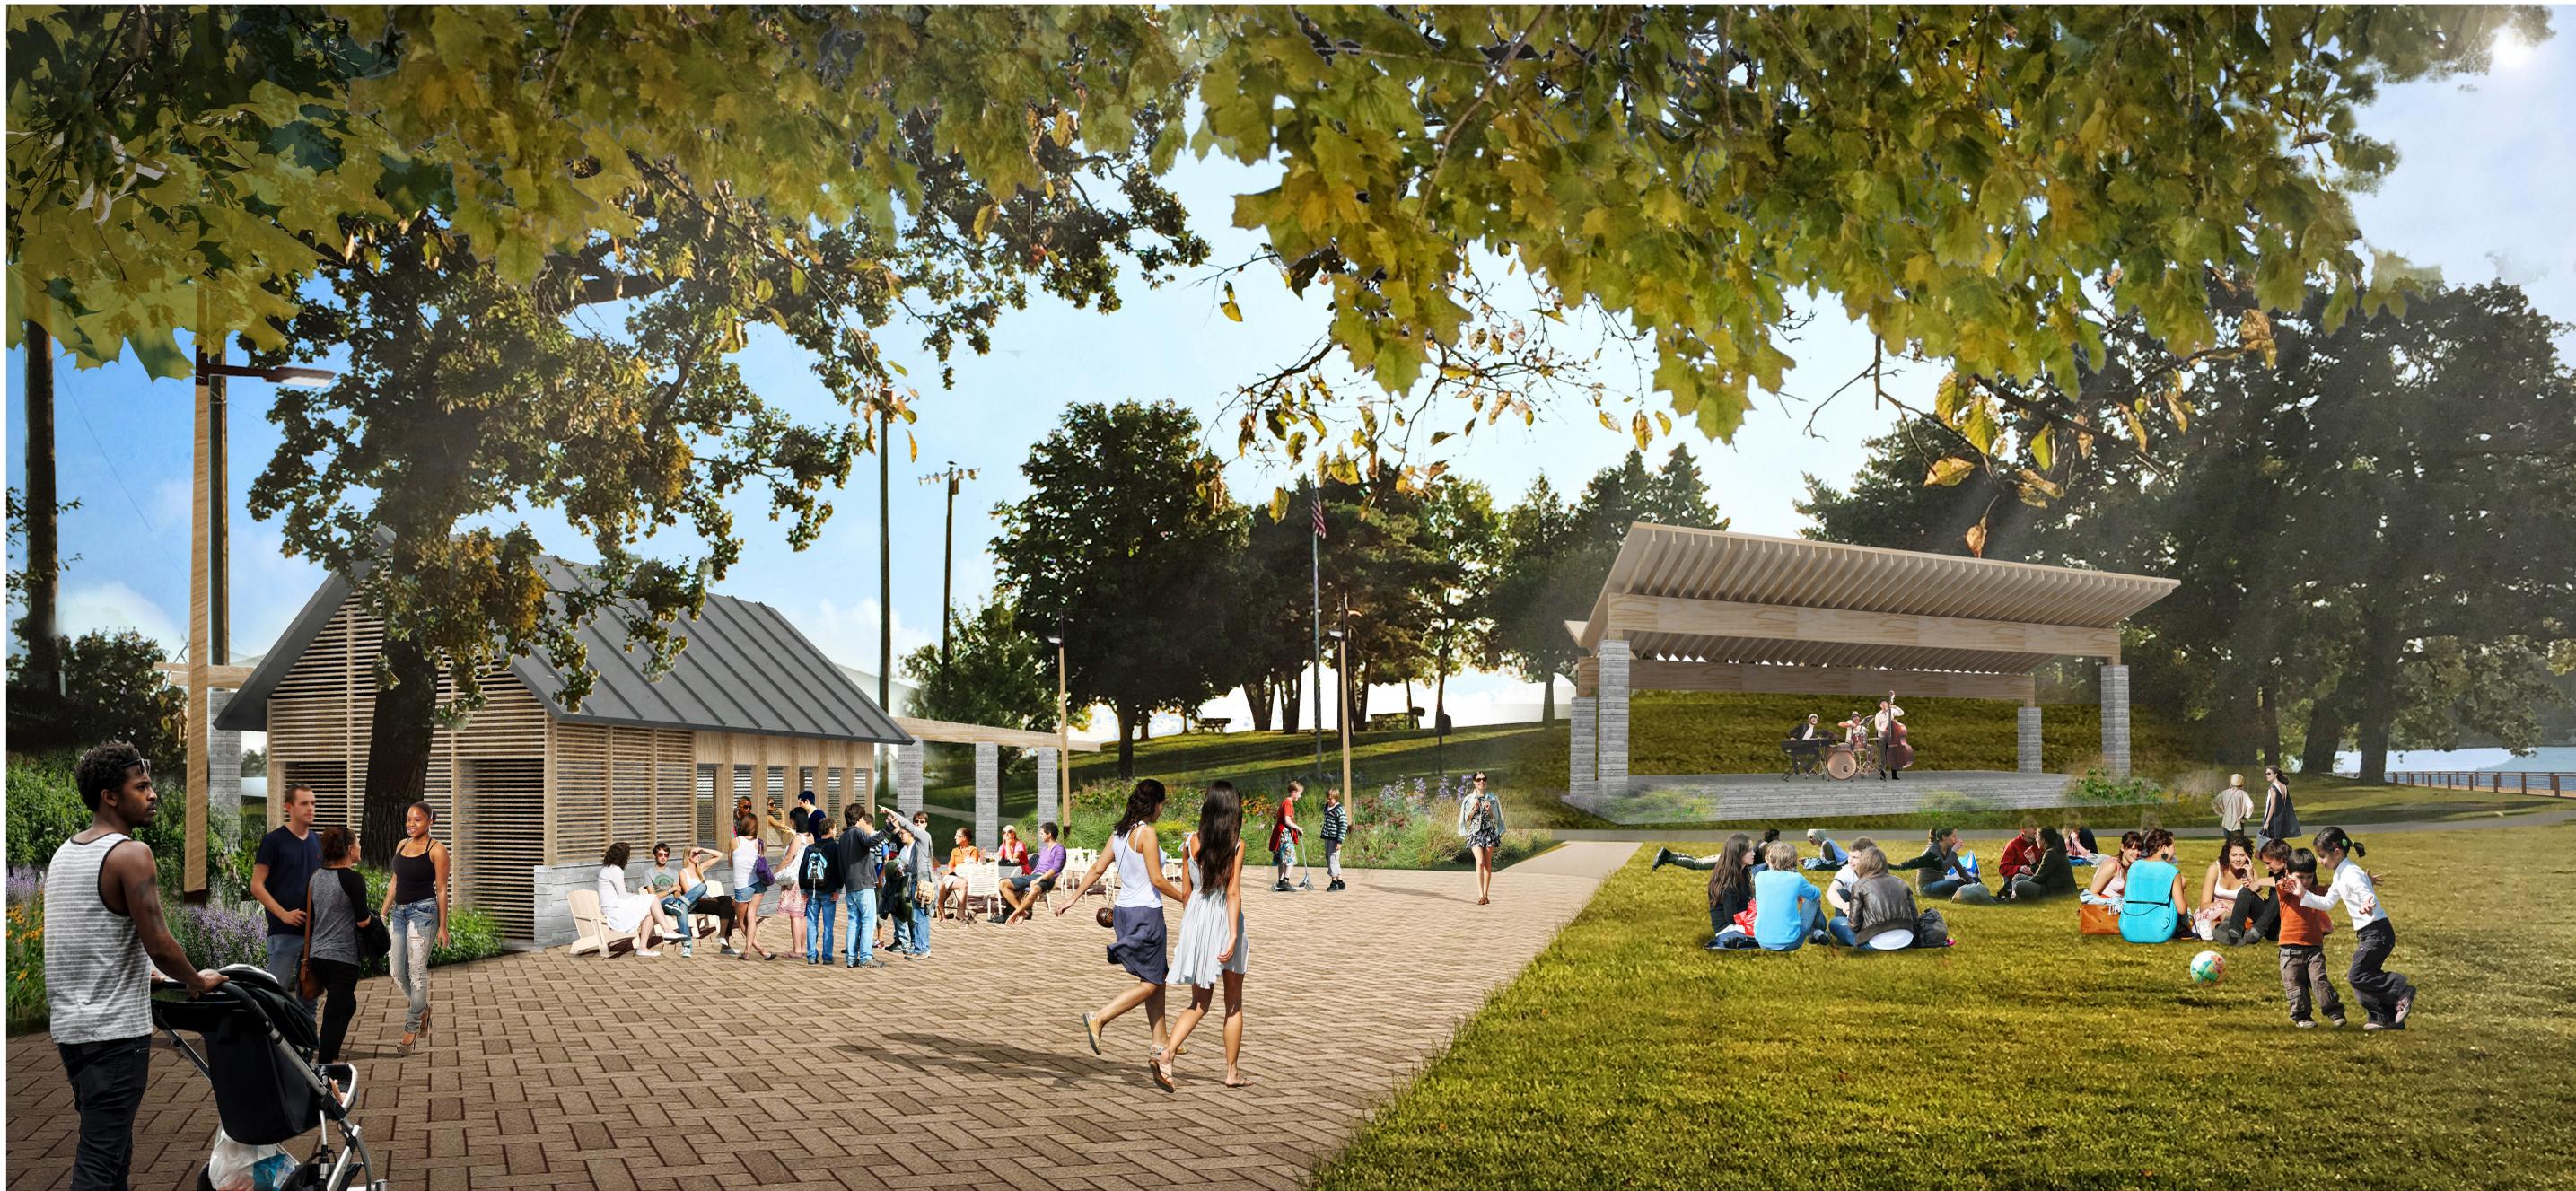
LAWN AND BALLFIELD AREA IMPROVEMENTS

This illustration depicts a new two sided bandshell with tiered seating on the knoll for more intimate events and a large stage facing the open lawn for large community events. The asphalt driveway has been replaced with a permeable paver plaza that allows for vehicles but feels more pedestrian in nature. The concession stand and bathroom building has been replaced with more modern amenities and access on both sides to serve events on the open lawn and ballfield. A picnic shade structure extends from the concession stand towards the Lake to accommodate picnicking. New infiltration areas filter storm water and invasive species on the knoll have been removed to open new views of the Lake.
